PROPOSED LARGE-SCALE RESIDENTIAL DEVELOPMENT OF BLOCKS B1 & C
AT 42A PARKGATE STREET, DUBLIN 8
ARCHITECTURAL HERITAGE IMPACT ASSESSMENT

November 2024

Arc Consultants have been commissioned by the applicant, Ruirside Developments Ltd, to prepare this Architectural Heritage Impact Assessment (AHIA) to accompany a planning application for a Large-scale Residential Development (LRD) at Block B1 and Block C located at No. 42A Parkgate Street, Dublin 8.

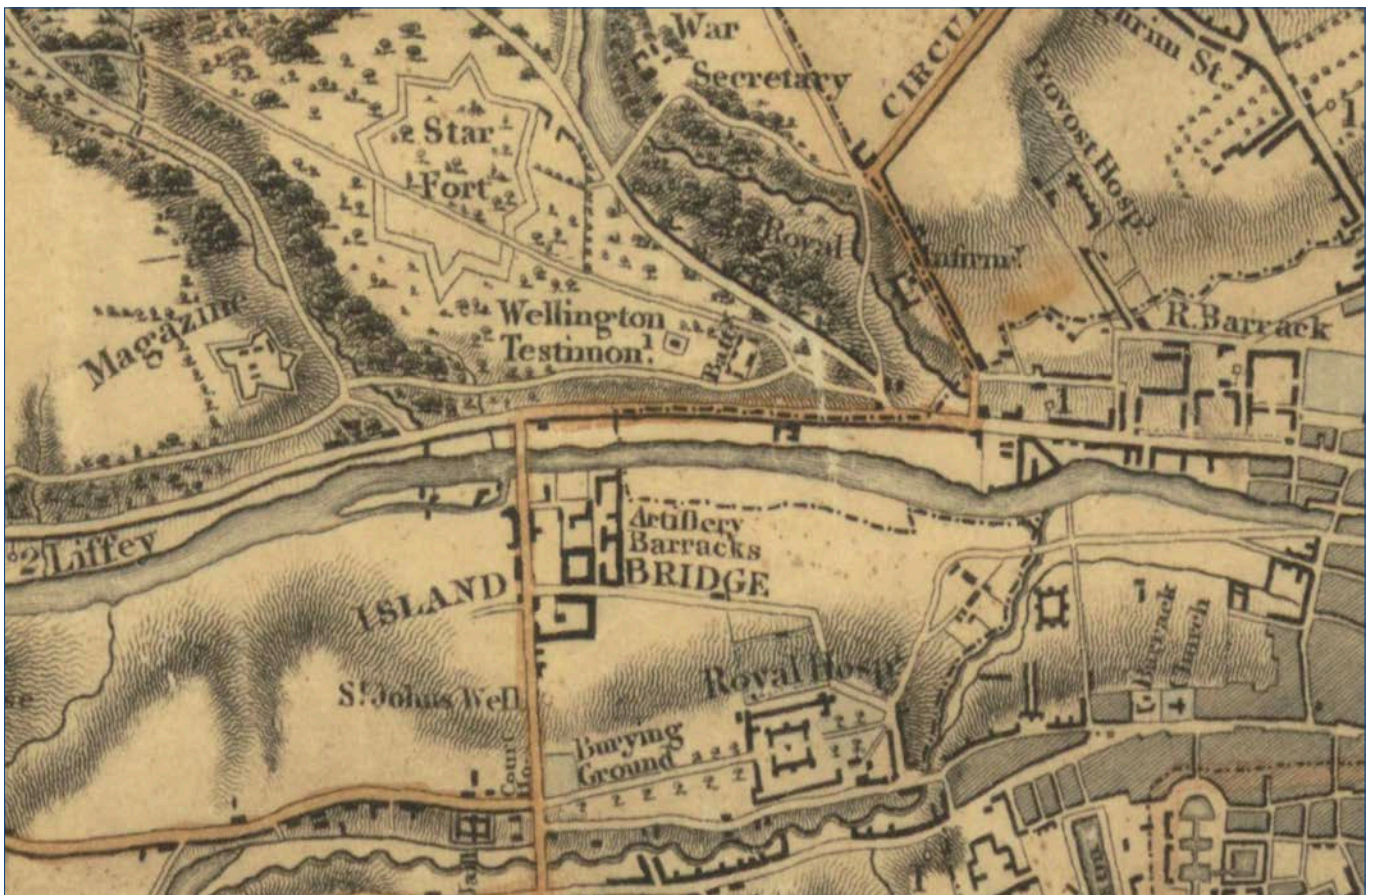
Extract from Duncan's Map of Dublin of 1821. The map indicates a triangle of buildings and two other small buildings on the subject site. At that date the surrounding area of the city and all the lands to the south and west are dominated by military buildings and institutions. The Wellington Testimonial, construction of which would only have just started, is shown in the centre of a group of military buildings: the Magazine Fort, the Royal Infirmary, the Royal Barracks, The Royal Hospital and the Artillery Barracks.

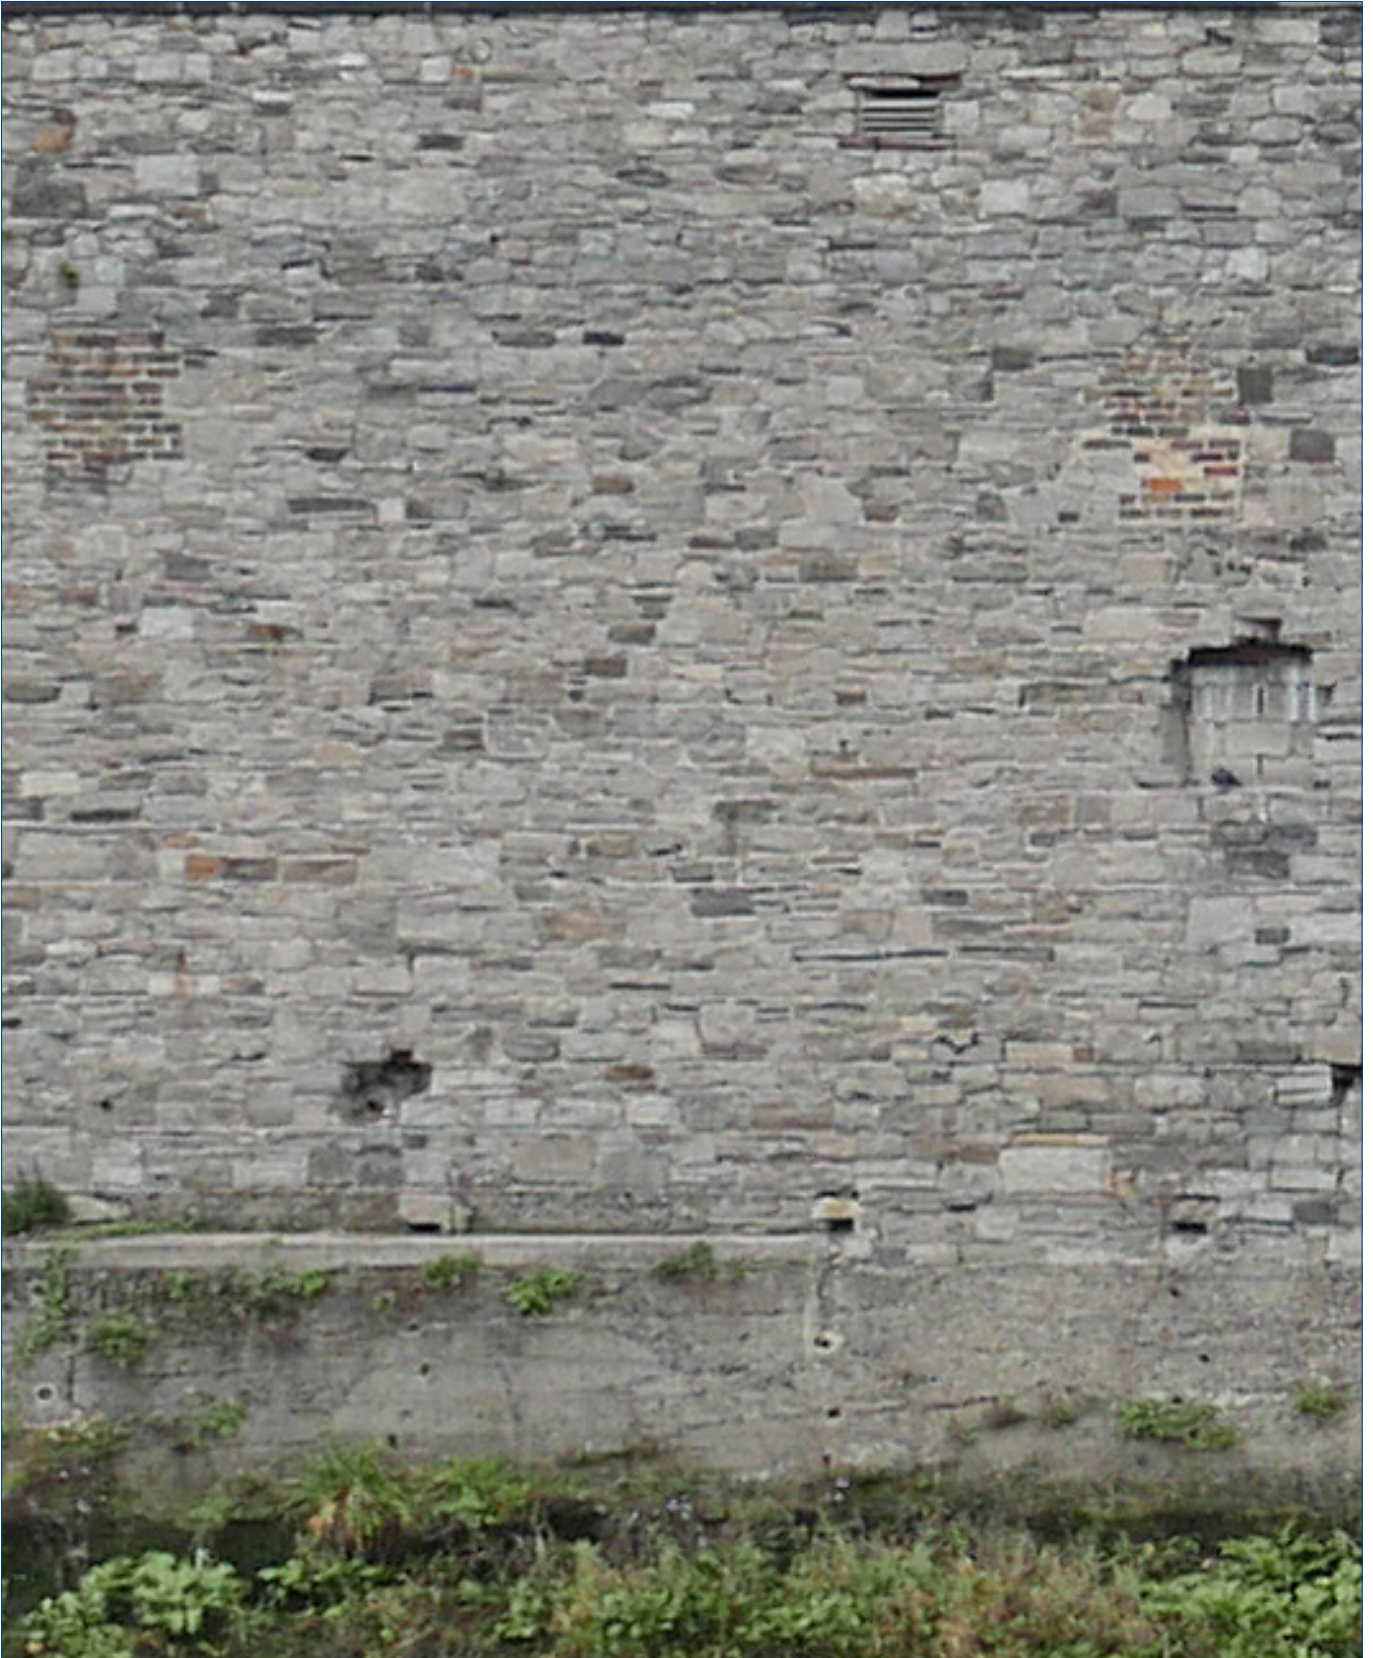
Riverside Stone Wall

Close-up view of part of the Riverside Stone Wall. The wall is constructed of limestone in a coursed rubble pattern. The courses (dayworks) appear to range in height from 375mm to 400mm. This is less than the more normal 460mm (18 inches) and could suggest that the stone is second hand coming from former buildings on the site. The stonework pattern is less regular towards the top of the wall, and the stones near the top of the wall are smaller.

As part of the proposals for the new development, its proposed to alter the riverside wall, a Protected Structure. The alterations include partial demolition of the wall so as to create new openings, including one very large opening. The purpose of the new openings is to provide open views south onto the River and towards Heuston Station from a new public plaza within the proposed scheme. It is also proposed to enlarge some existing openings in the wall and to repair others, including filling existing openings with new coursed rubble limestone stonework to match the pattern of the existing wall. Approximately 24% of the superstructure of the wall above the water line will be removed to make the new openings. It is also proposed to repair the existing parapet of the wall replacing any decayed parapet stones with new stones of the same profile

The loss of substantial areas of original fabric from the wall will result in significant negative effects on the architectural heritage of the wall. The repair works to the riverside wall are likely to give rise to positive effects on the heritage of the wall. Works to the wall are permitted under ABP-306569-20.

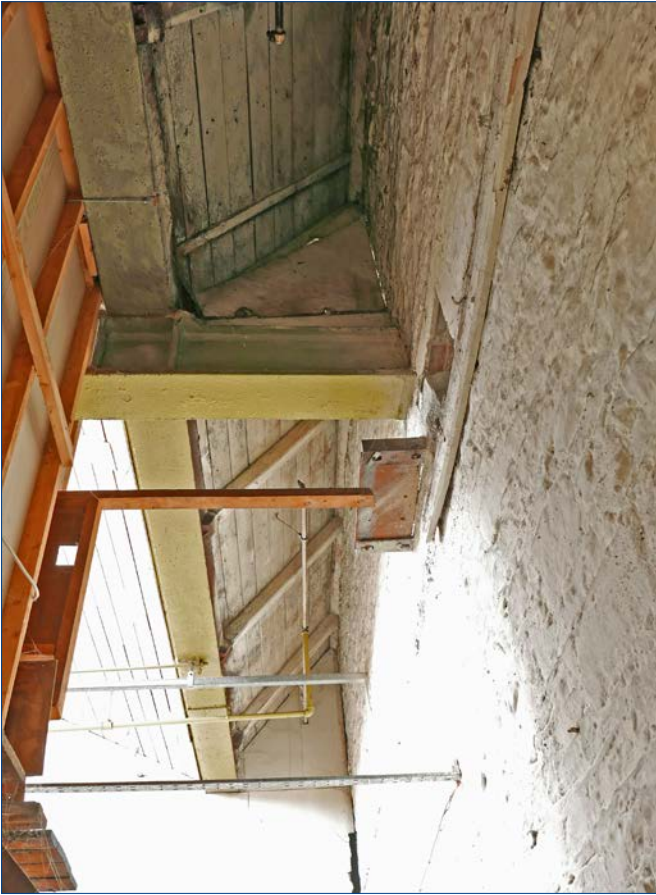
Inside of the Riverside Stone Wall, looking east and upwards near the east end of the wall. At the east end of the warehouse, two cast iron roof beams continue to the Riverside Stone Wall. The rest of the beams do not

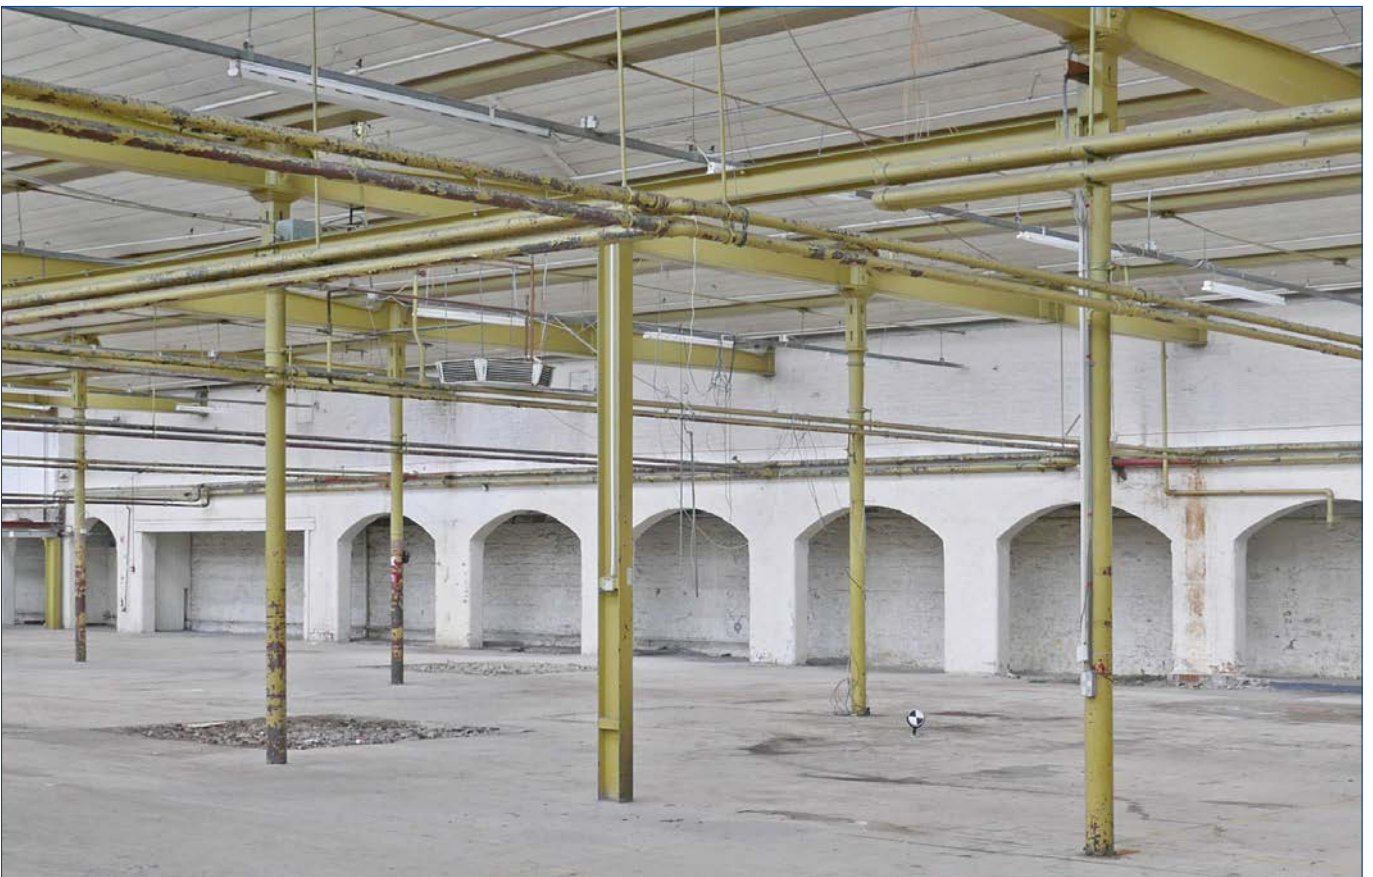
View in the Warehouse, looking south towards the arches of the separate inner brick wall. In all but two cases, the cast iron beams supporting the roof stop at the inner wall and do not continue to the Riverside Stone Wall.

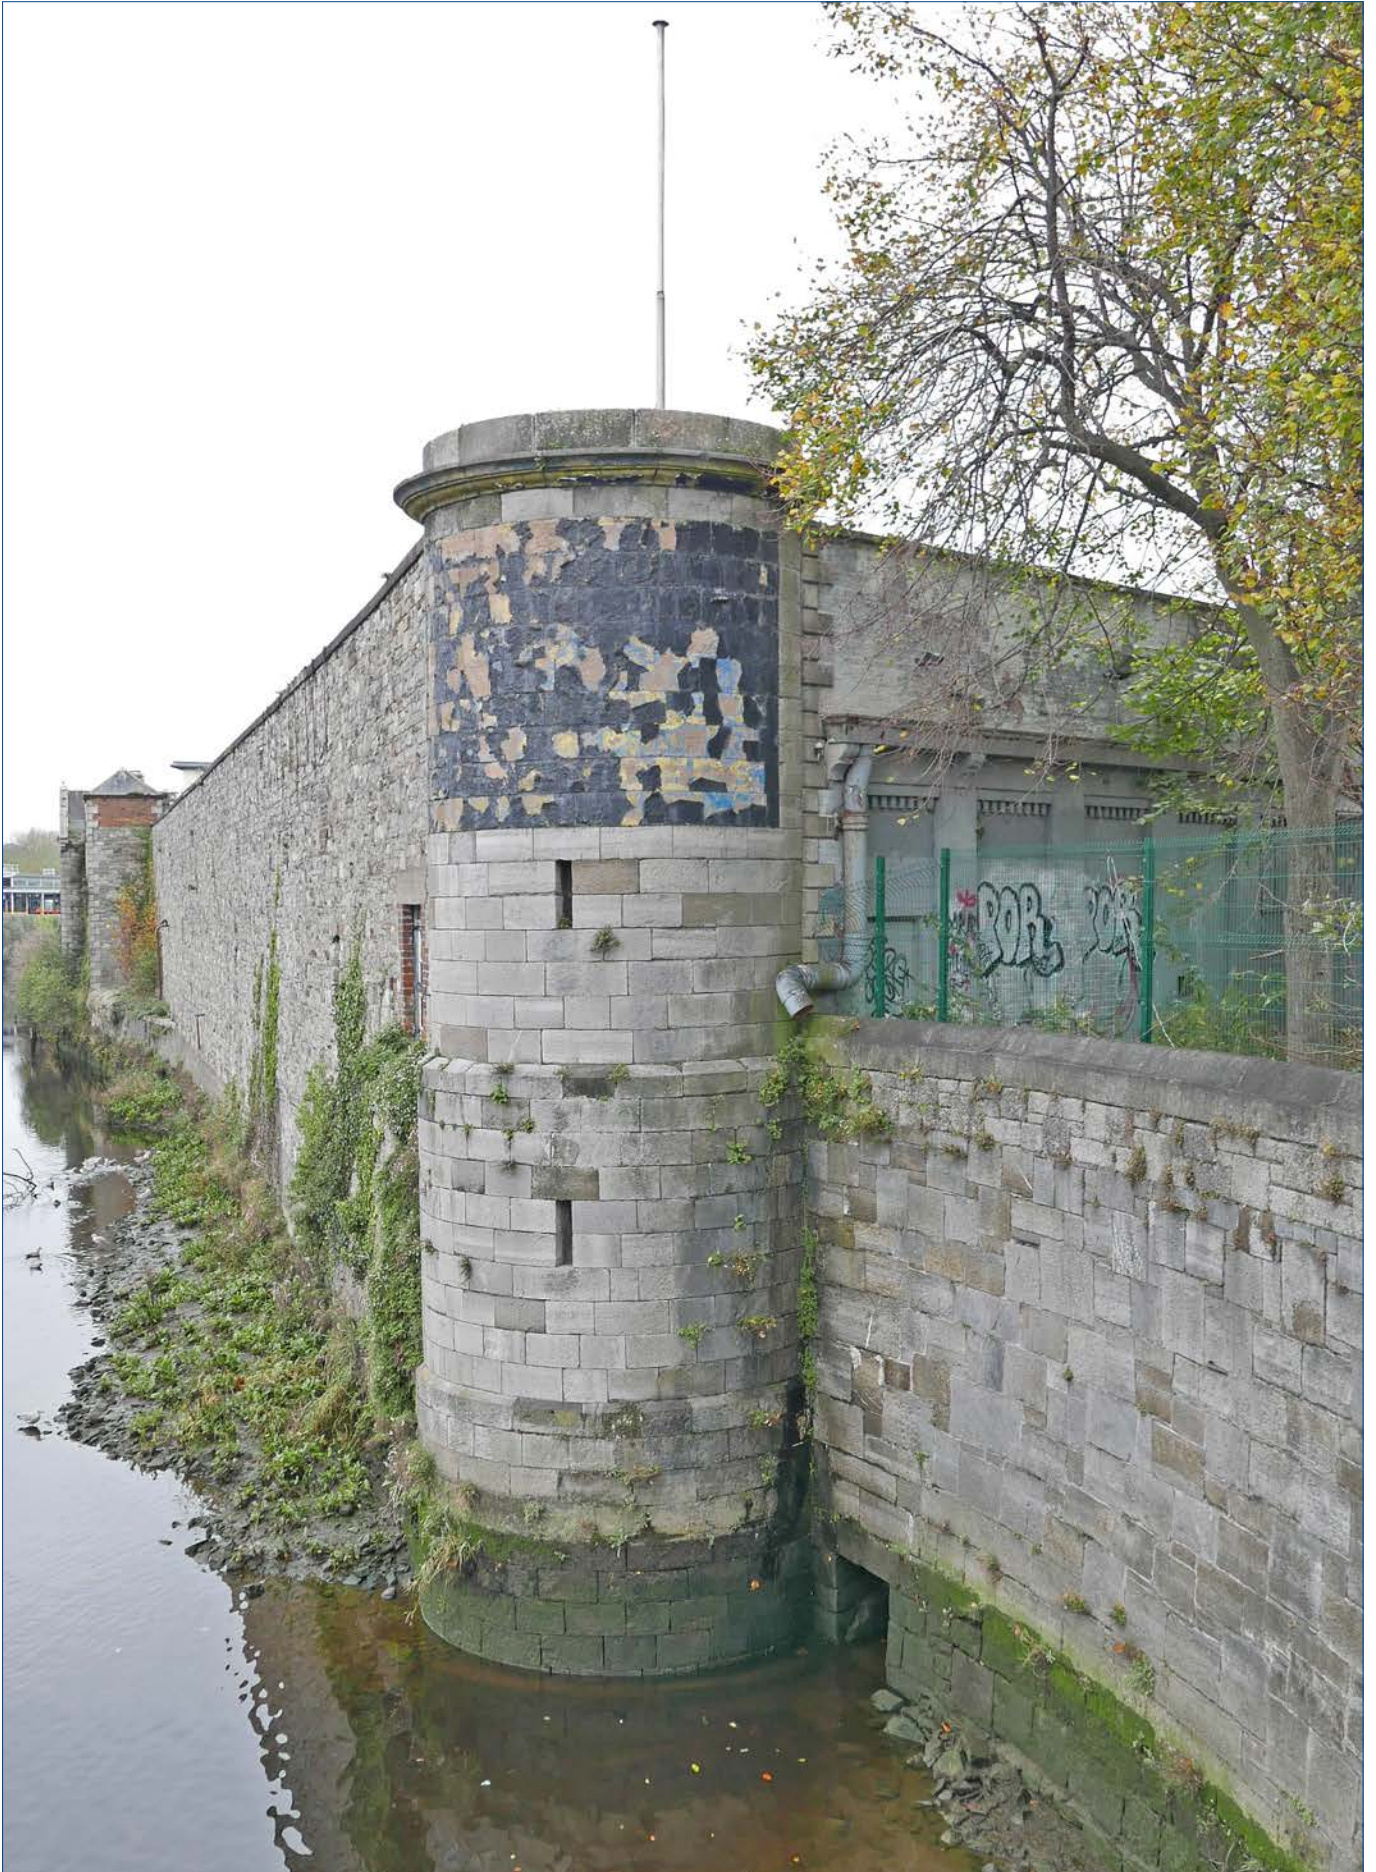
Turret at the Eastern End of Site

The turret is constructed in the main of cut limestone in an ashlar pattern. The cornice and blocking course are in granite. The Turret appears visually to be in relatively good condition though there is a need for some careful non-aggressive stone cleaning, removal of plants, and minor stone and pointing repair. The opening in the flank wall near the foot of the Turret is where the Viceregal Stream enters the River Liffey

The turret is constructed in the main of cut limestone in an ashlar pattern. The cornice and blocking course are in granite. The Turret appears visually to be in relatively good condition though there is a need for some careful non aggressive stone cleaning, removal of plants, and minor stone and pointing repair. Any appropriate repair works to the Turret are likely to give rise to positive effects on the heritage of the Turret, and on the surrounding architectural heritage.

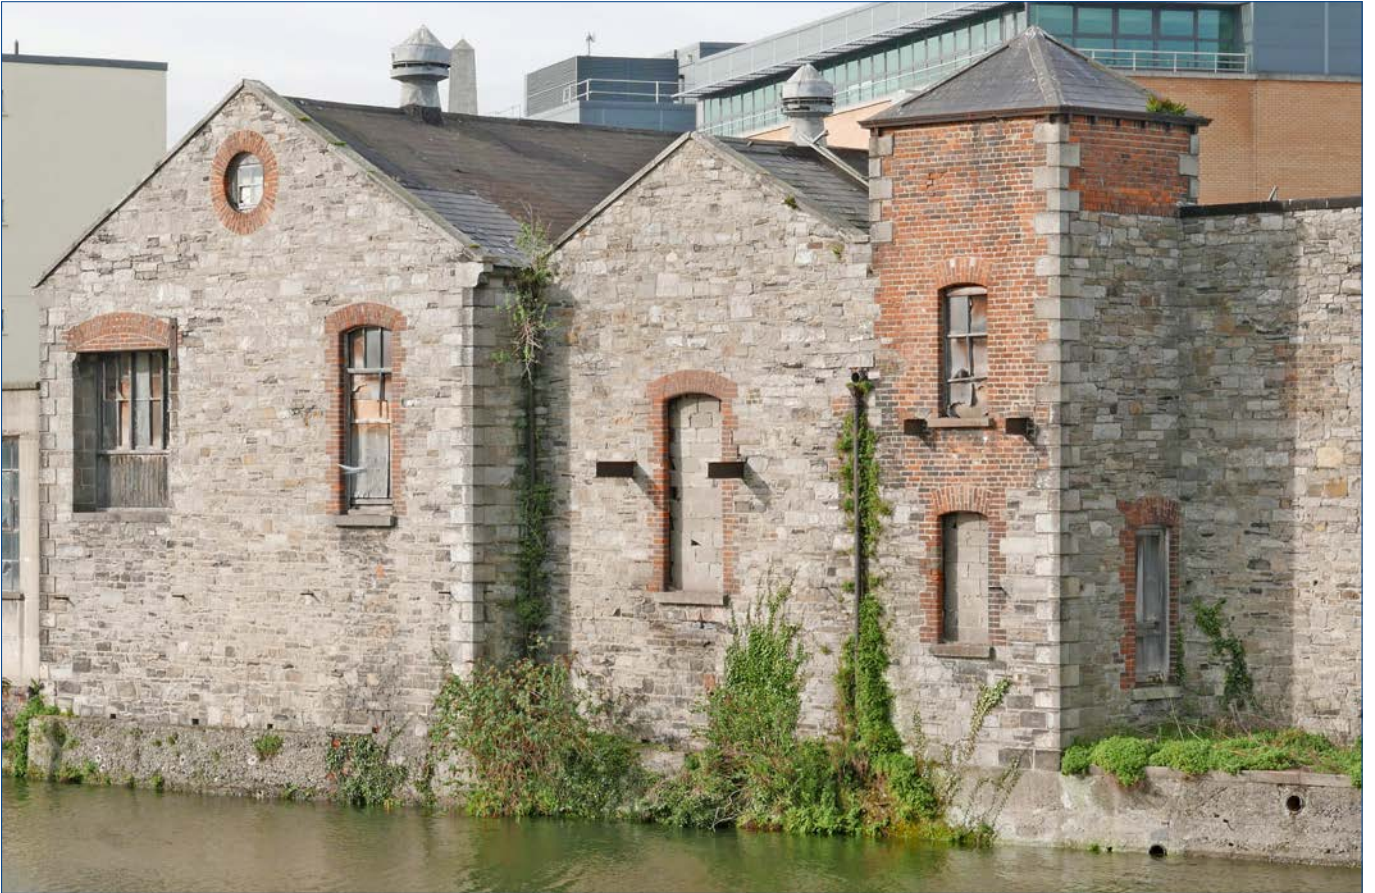
Square Tower on the Riverfront

Oblique view of the river buildings, looking north west. The shape of the shadow of the square tower on the river wall suggests that the upper half of the river wall tilts back at that point. There is an opening on the east side of the Square Tower, a former door or window. It is proposed to fit a simple modern window into this opening.

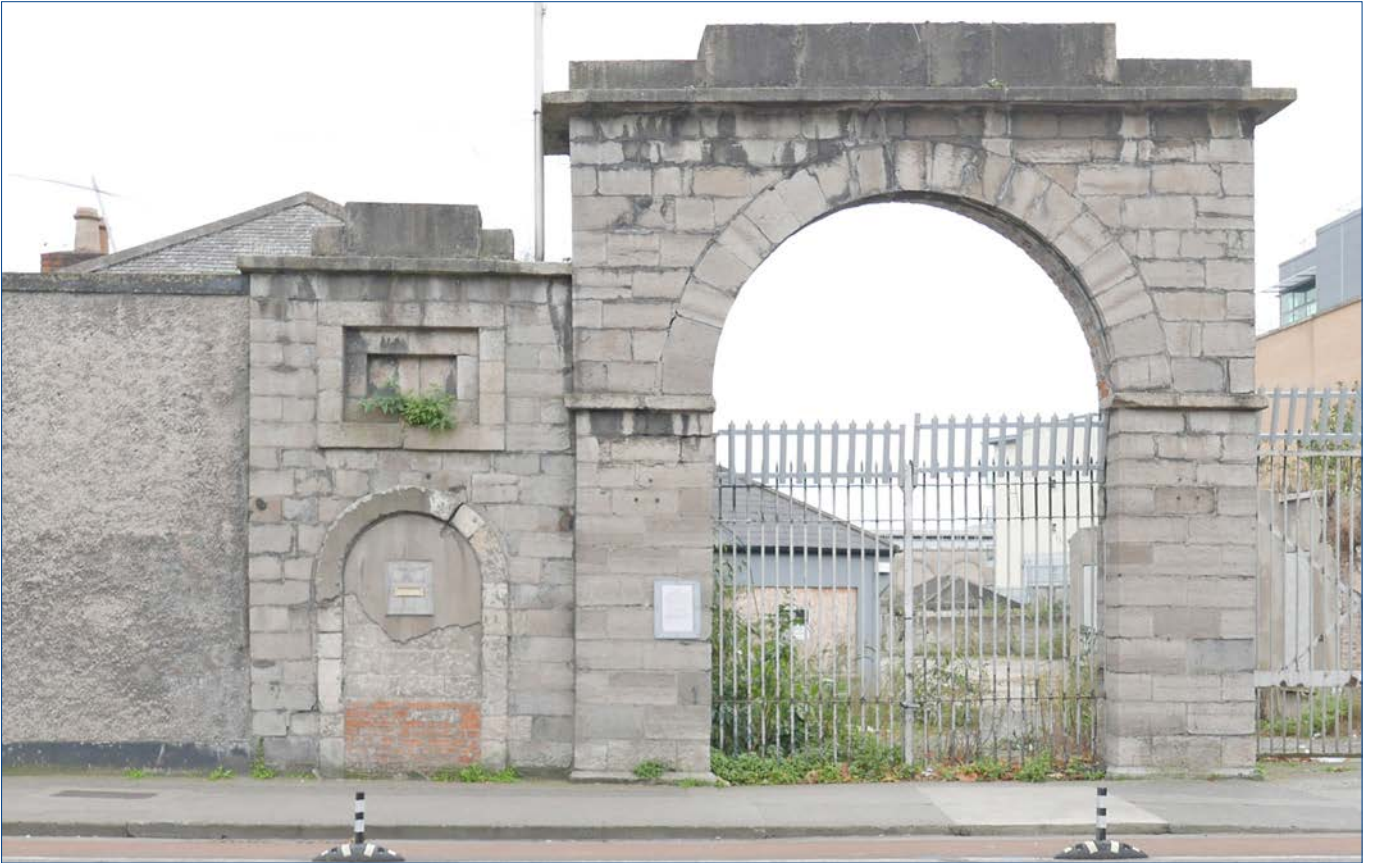
Entrance Stone Arch on the Parkgate Street Frontage

The gateway is constructed mainly of limestone, with granite details. The projecting string course and blocking courses above are granite. The partly stripped rendered area in the eastern wing covers granite dressed stonework in a distressed condition, surrounding a former round headed opening that perhaps gave into a gate lodge or entrance building behind. The rectangular panel above is granite. The granite elements of the gateway have suffered much more decay than the lime stone and will need extensive repair or, in some cases, replacement

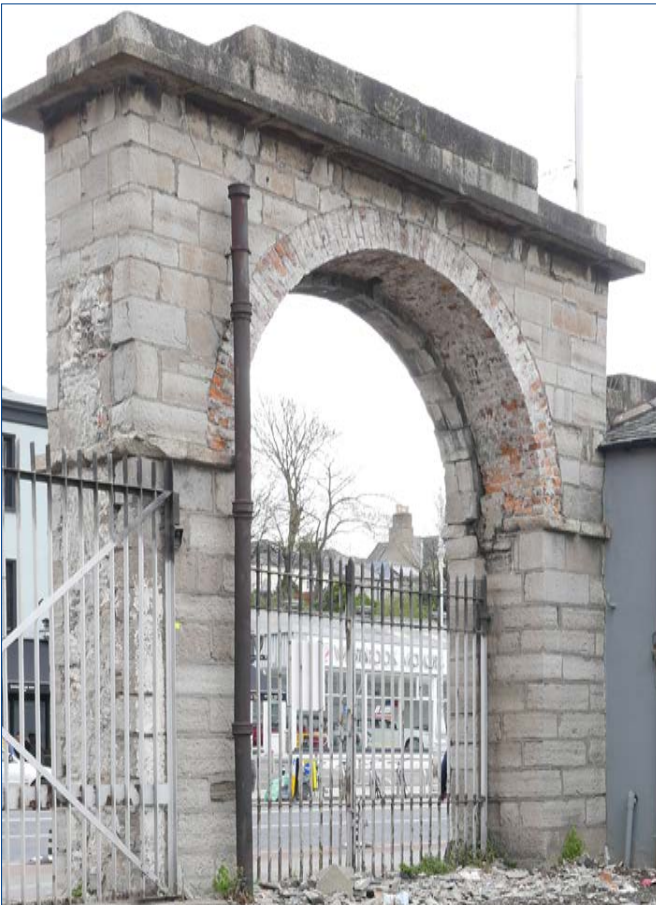
View of the inside of the gateway after removal of cementitious render from the inner brick arch. the brickwork may have had a lime render originally or may have been exposed

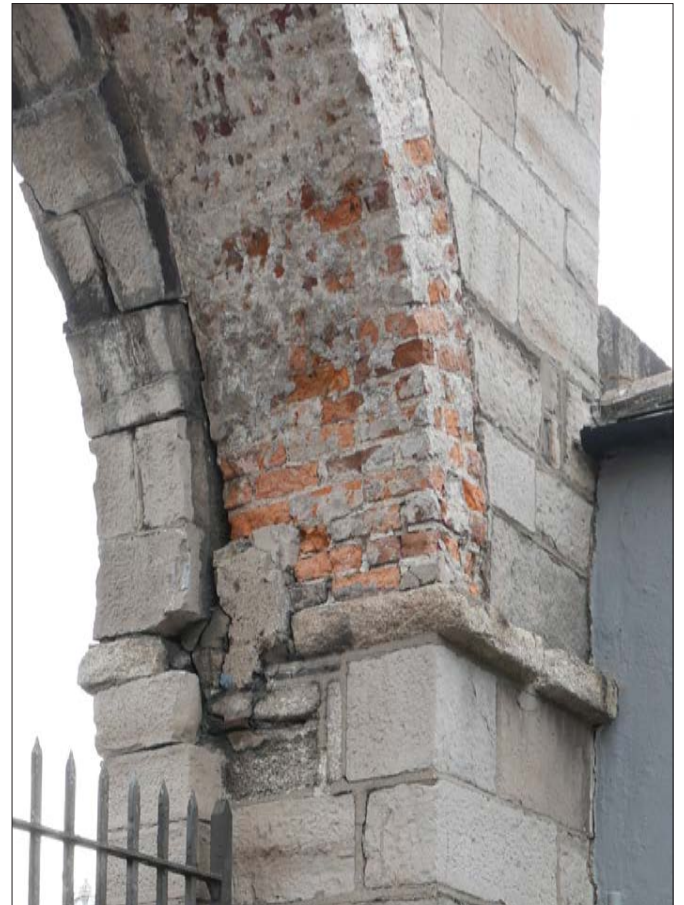
Detail of the springing of the stone and brick arches, showing the decay of the granite string course and evidence of structural movement

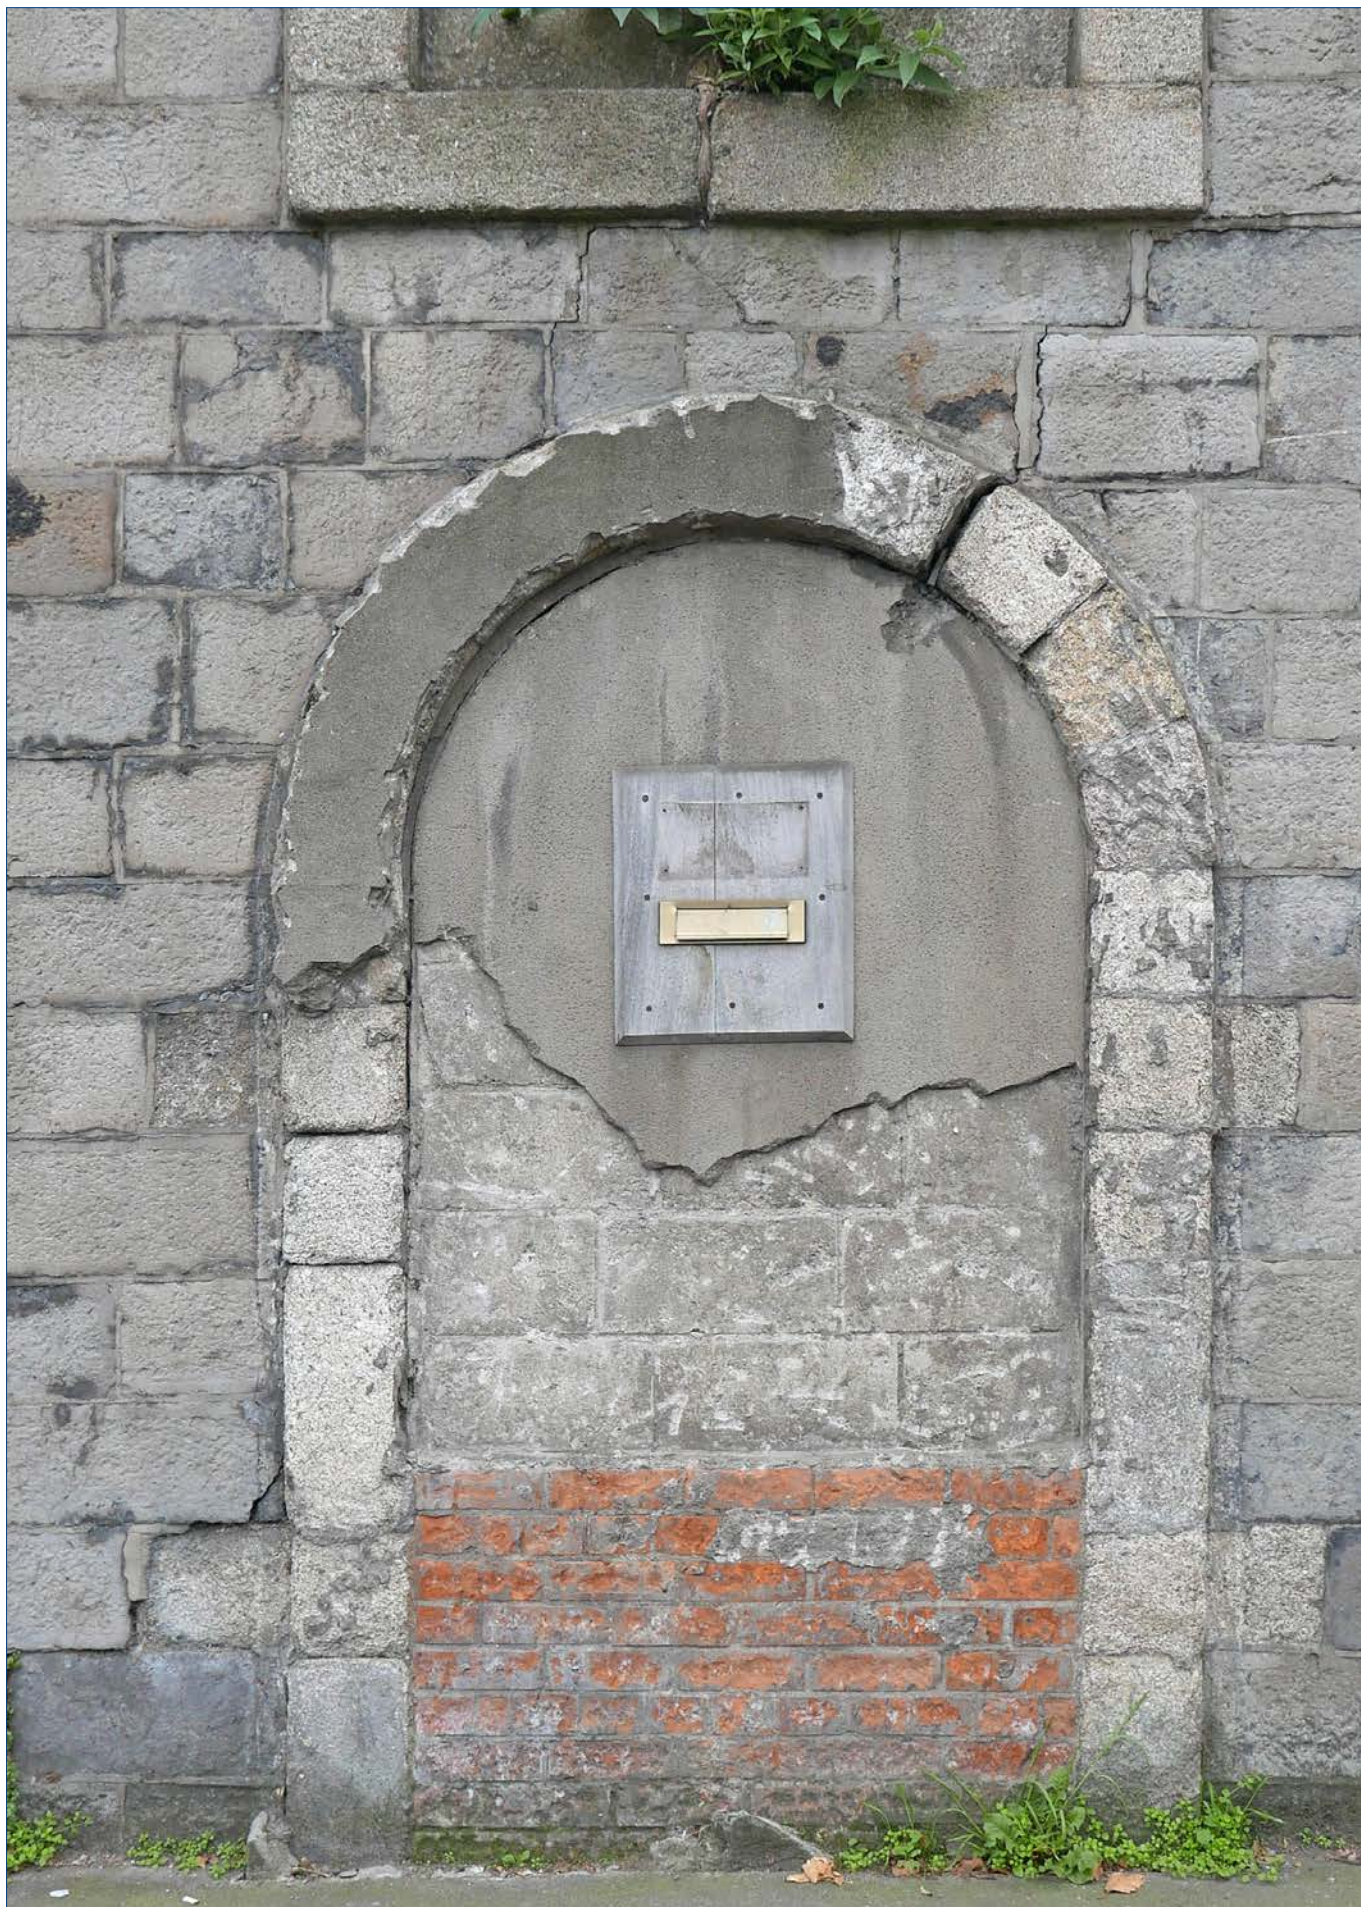
Entrance Stone Arch on the Parkgate Street Frontage

Arched side entrance in the eastern flank wall to the gateway. Perished granite stonework can be seen where areas of render has been stripped off. Originally there may have been a round headed doorway, a window opening, or possibly simply a recessed panel.

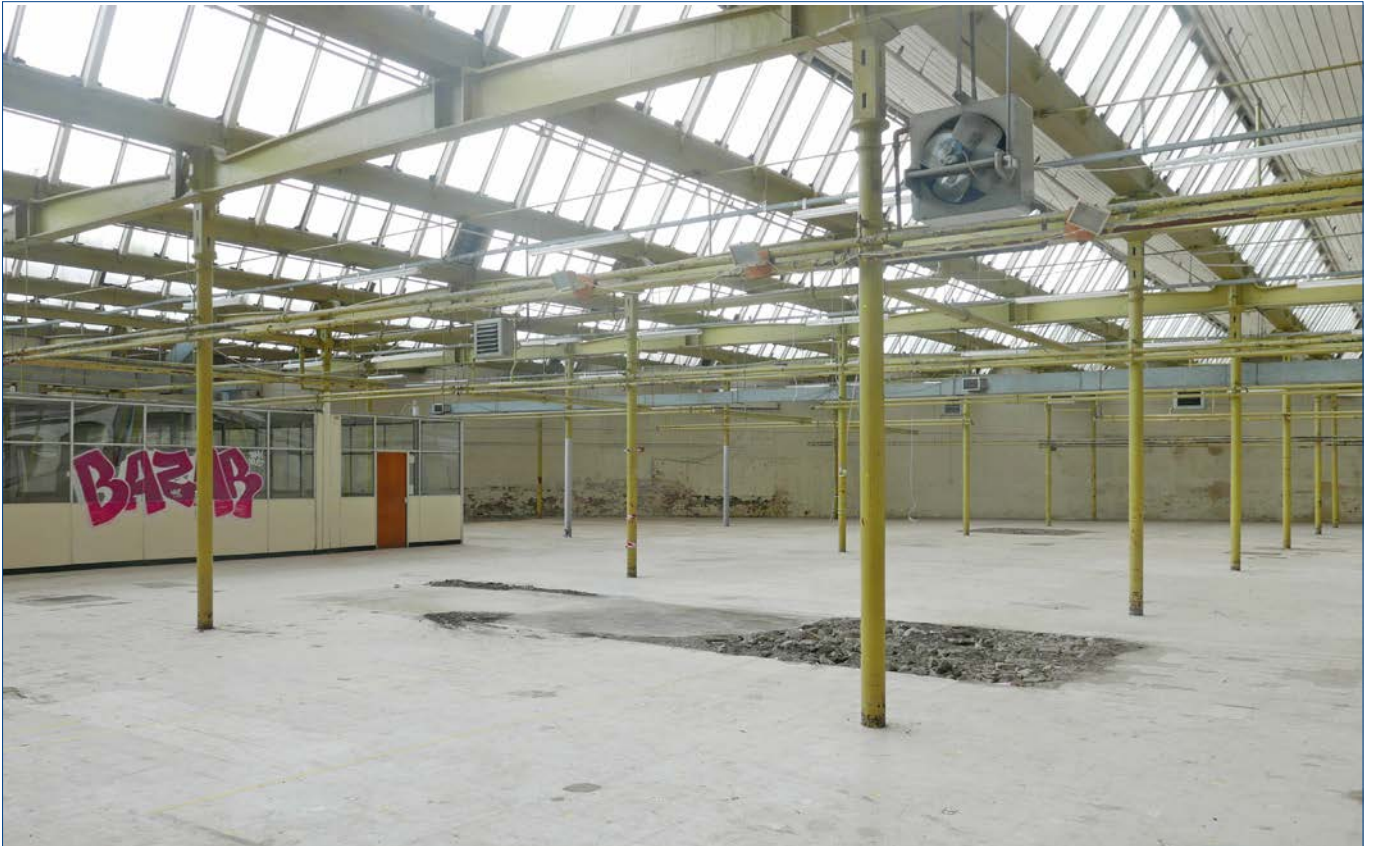
View looking west from the centre of the main Warehouse. The Warehouse is roughly triangular on plan. On the southern side, there is an inner brick wall, parallel to but not as long as the Riverside Stone Wall. On the east side, and curving around to the north, there is high grey painted brick wall along Parkgate Street. To the west and north there are also brick walls. The surrounding brick walls support the ends of the cast iron beams and gutters.

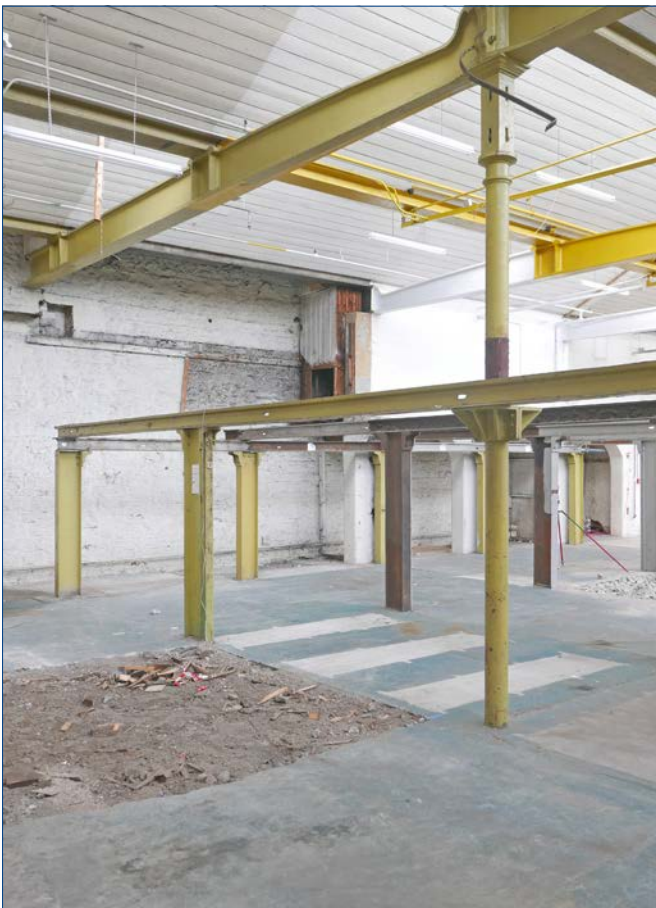
Mezzanine structure near the south west corner of the Warehouse. One of the main columns is seen with a collar supporting two lengths of tram track passing at right angles. One special extended main roof beam continues to the external Riverside Wall

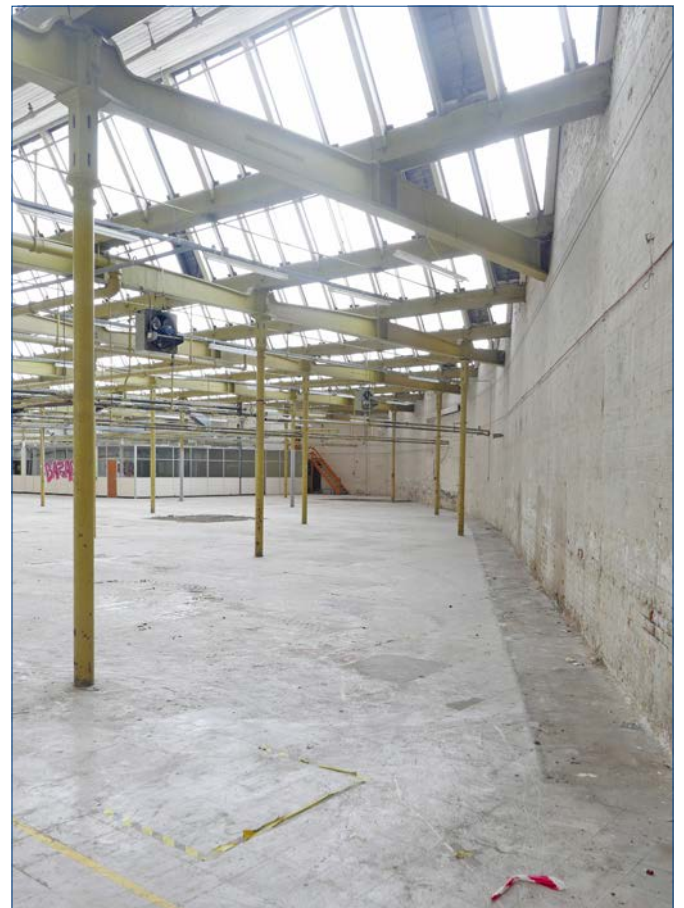
View of the interior of the large warehouse, looking north west. The curved brick wall to facing onto Parkgate Street is seen to the right, with cut back cast iron roof beams built into the wall.

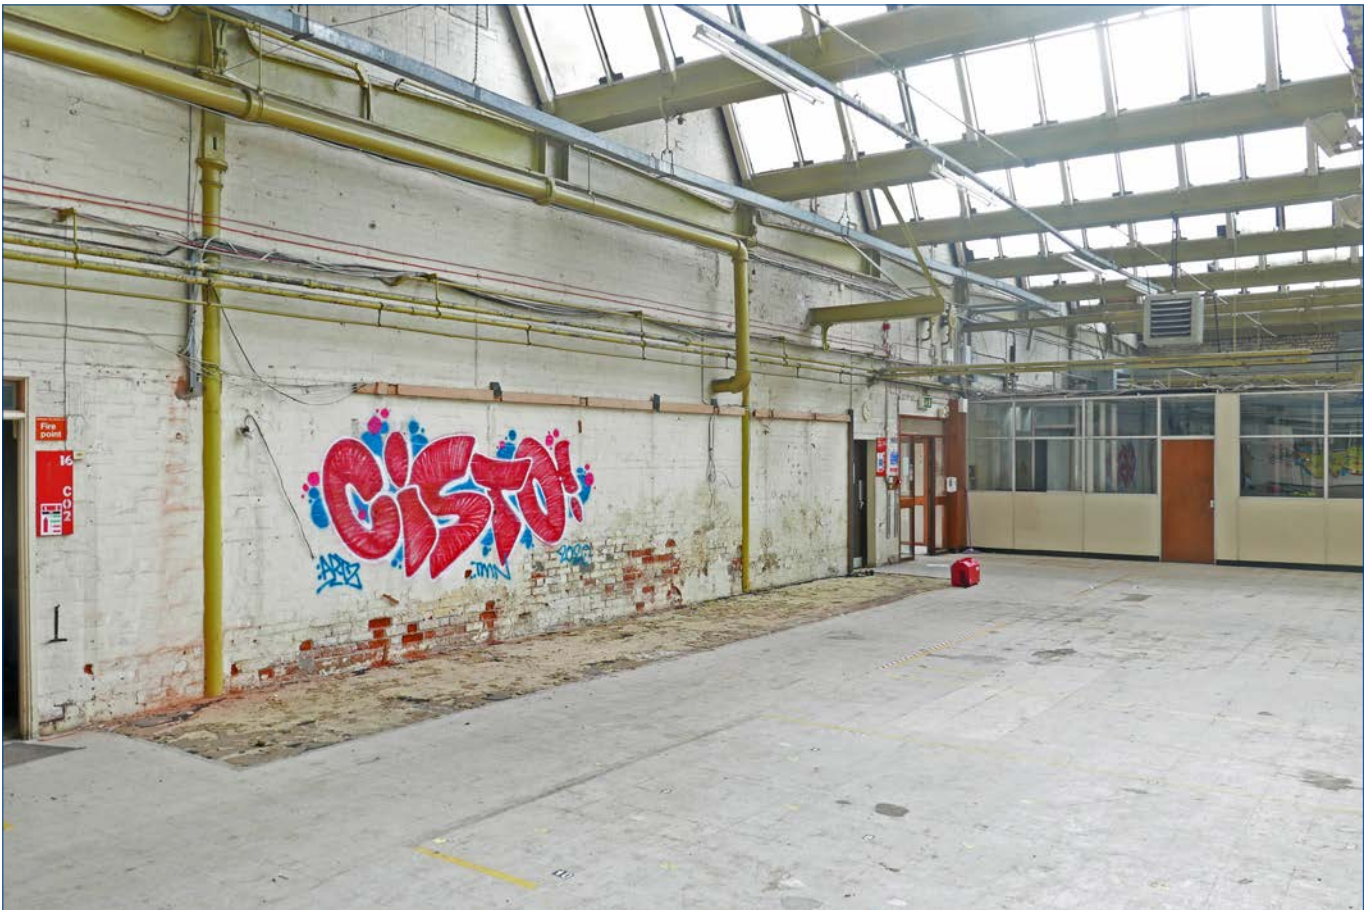
View in the Warehouse looking towards the north west corner. The 24 foot cast iron beams bear the name 'Courtney Stephens & Bailey'. These beams in turn support cast iron gutters spanning 12 feet that support the 'northlight' roof. It has not been possible to establish the origin of the columns supporting the roof beams.

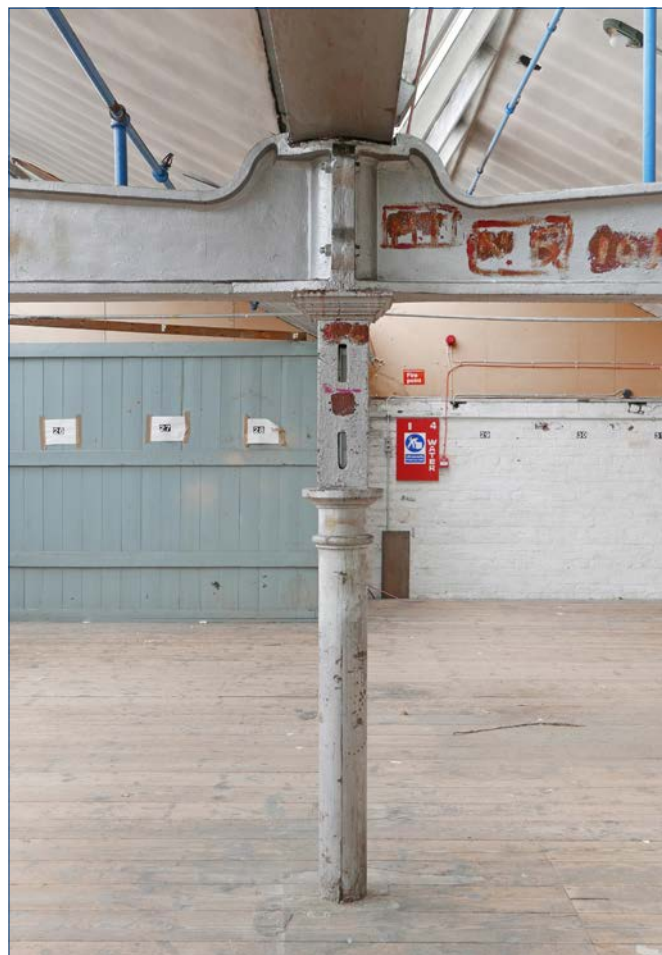
Detail at the head of a column showing the meeting of two roof beams and the cast iron gutter beam above.

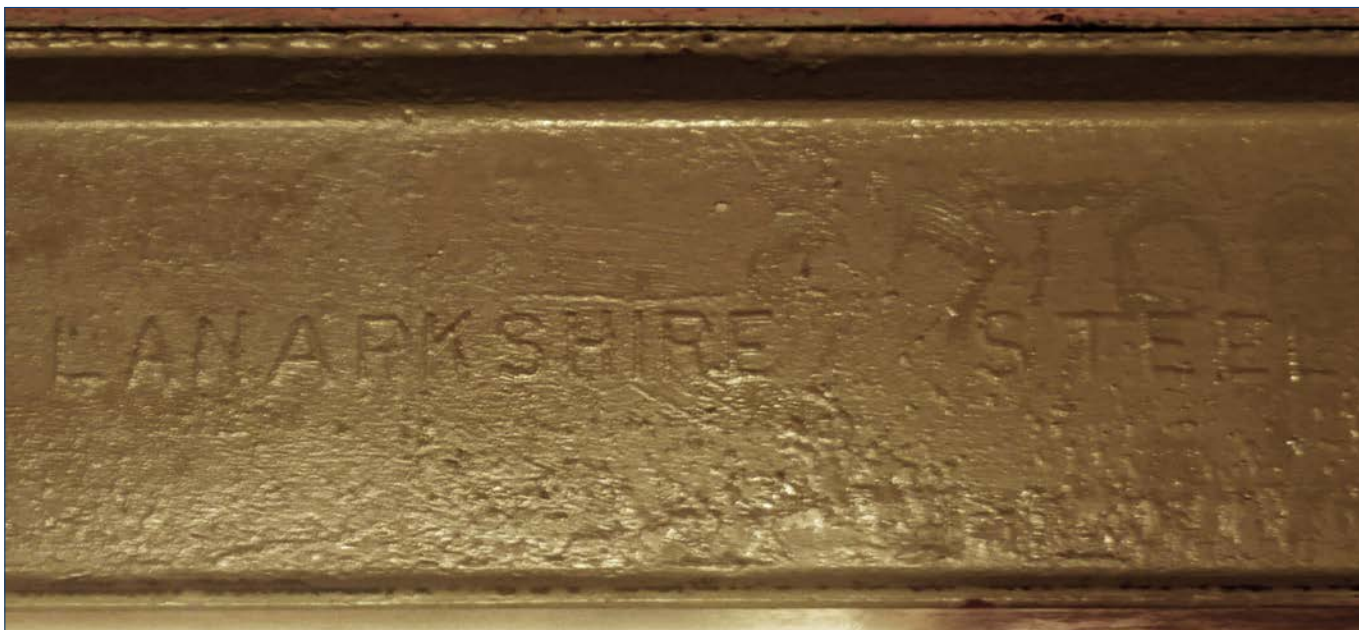
The name 'Lanarkshire Steel' marked on a rolled steel joist near the western side of the Warehouse.

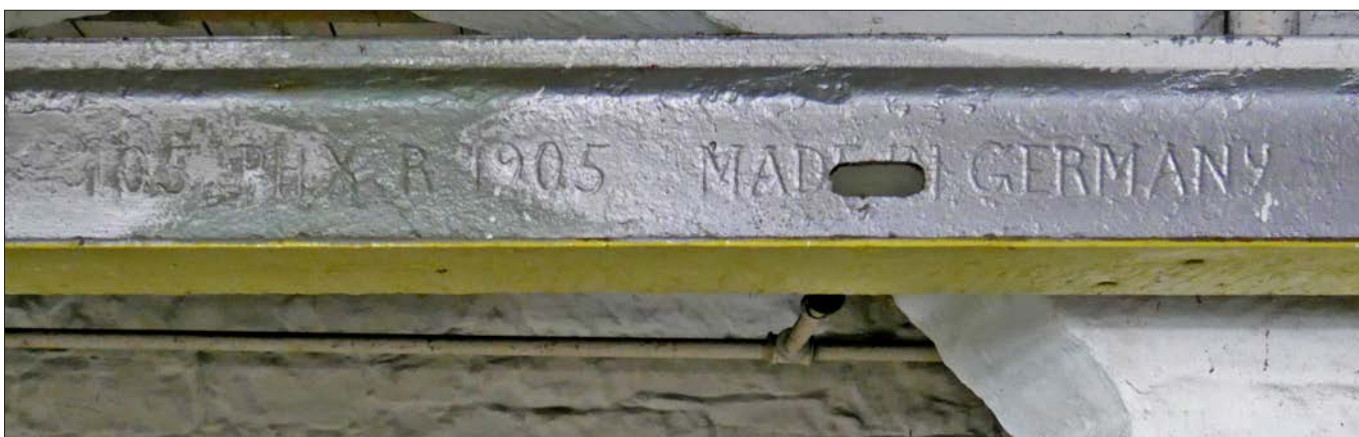
'105 PHX R 1905 Made in Germany' marked on a length of tram track forming part of a mezzanine structure near the south wall of the Warehouse. It is possible that the mezzanine was built when the building was a munitions factory, making shells to fire at the Germans.

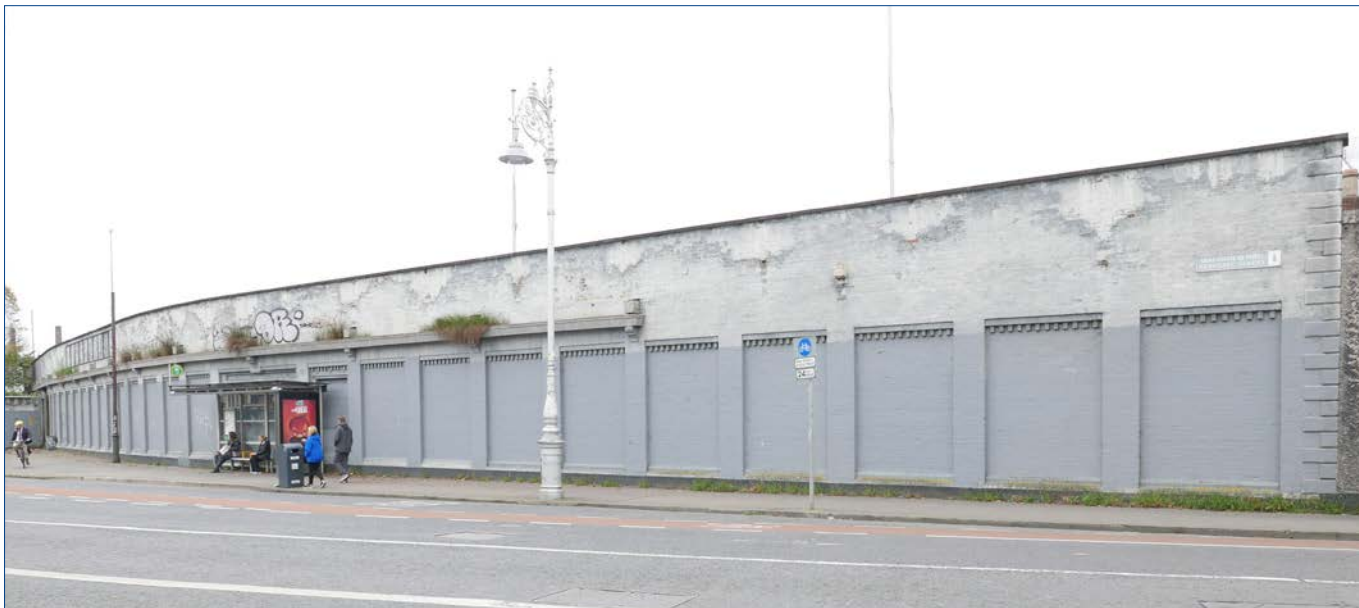
The long curved Wall of the Warehouse facing onto Parkgate Street

This wall, which is brickwork painted grey, was constructed with the rest of the warehouse between 1882 and 1886 under the direction of Edward C. Guinness, as part of the enterprise called Kingsbridge Woollen Works. The wall is not listed in the Record of Protected Structures, nor in the NIAH. It is a fine wall, or at least it was once, before the grey paint concealed its original character. Having been there for some 140 years it must have achieved the status of a rather dull local landmark. The loss of the wall will be a heritage loss, but without this loss there will be no real prospect of development on this site. The removal of the wall will permit the architecture of the new development to be expressed along Parkgate Street and will permit access from the street into a new public plaza facing south over the River. The loss of this wall will be a heritage loss, likely to give rise to 'moderate' negative effects on the architectural heritage of the surrounding area. The demolition of the wall is permitted under ABP-306569-20.
