PROPOSED LARGE-SCALE RESIDENTIAL DEVELOPMENT OF BLOCKS B1 & C
AT 42A PARKGATE STREET, DUBLIN 8
ARCHITECTURAL HERITAGE IMPACT ASSESSMENT

November 2024

Arc Consultants have been commissioned by the applicant, Ruirside Developments Ltd, to prepare this Architectural Heritage Impact Assessment (AHIA) to accompany a planning application for a Large-scale Residential Development (LRD) at Block B1 and Block C located at No. 42A Parkgate Street, Dublin 8.

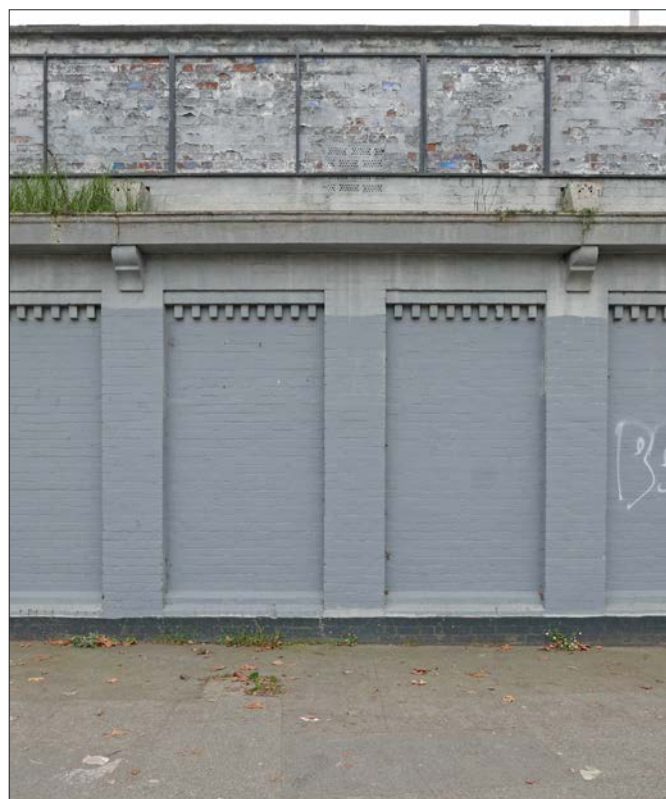
Typical bay of the wall of the warehouse facing onto Parkgate Street. Granite corbels carrying a moulded cast iron gutter with cast iron gutter beams over

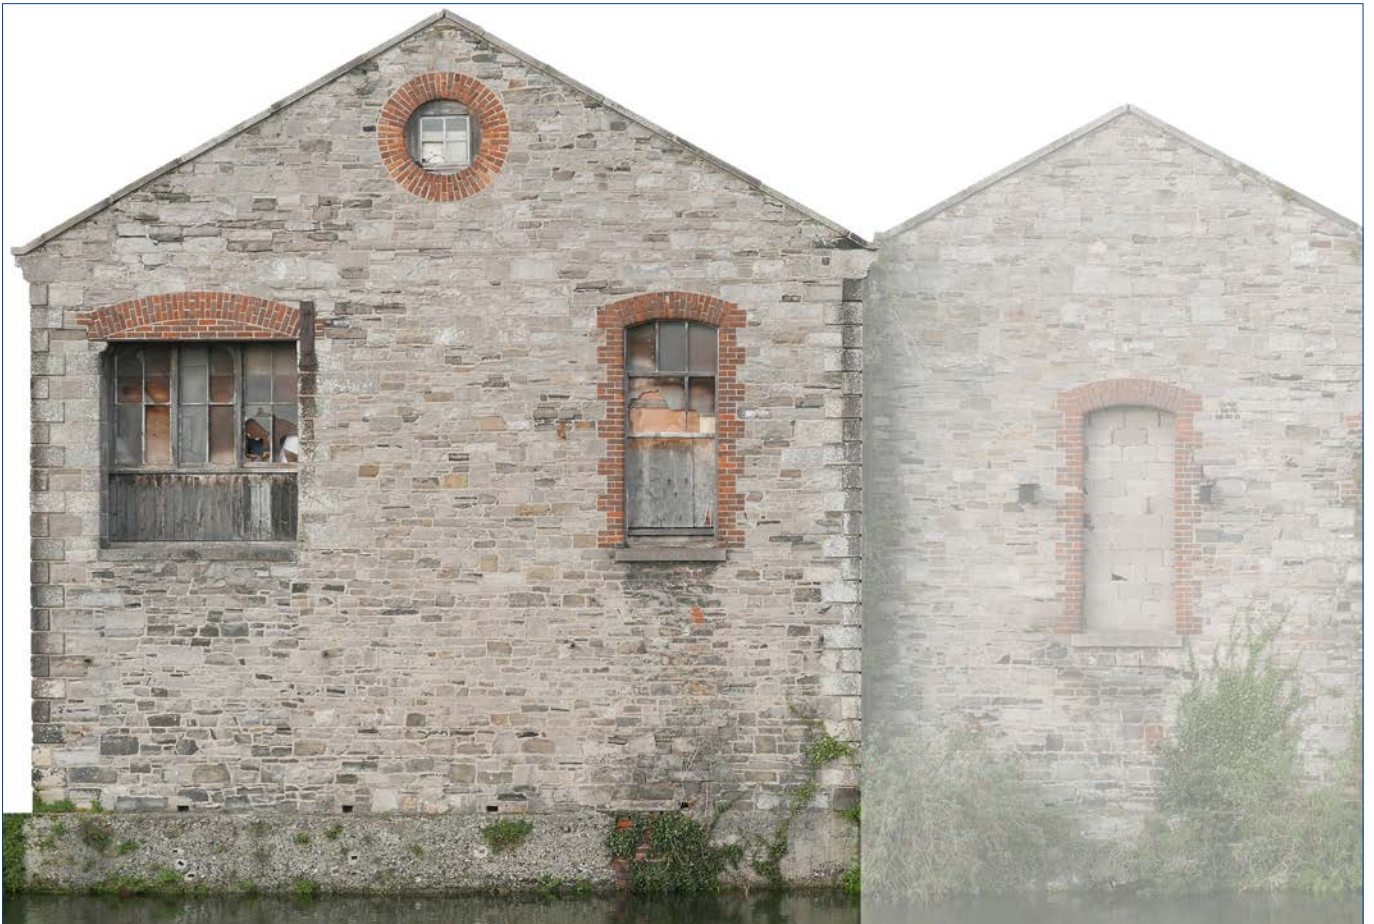
Rectified Elevation of the Larger Gabled Building • Scale 1:100

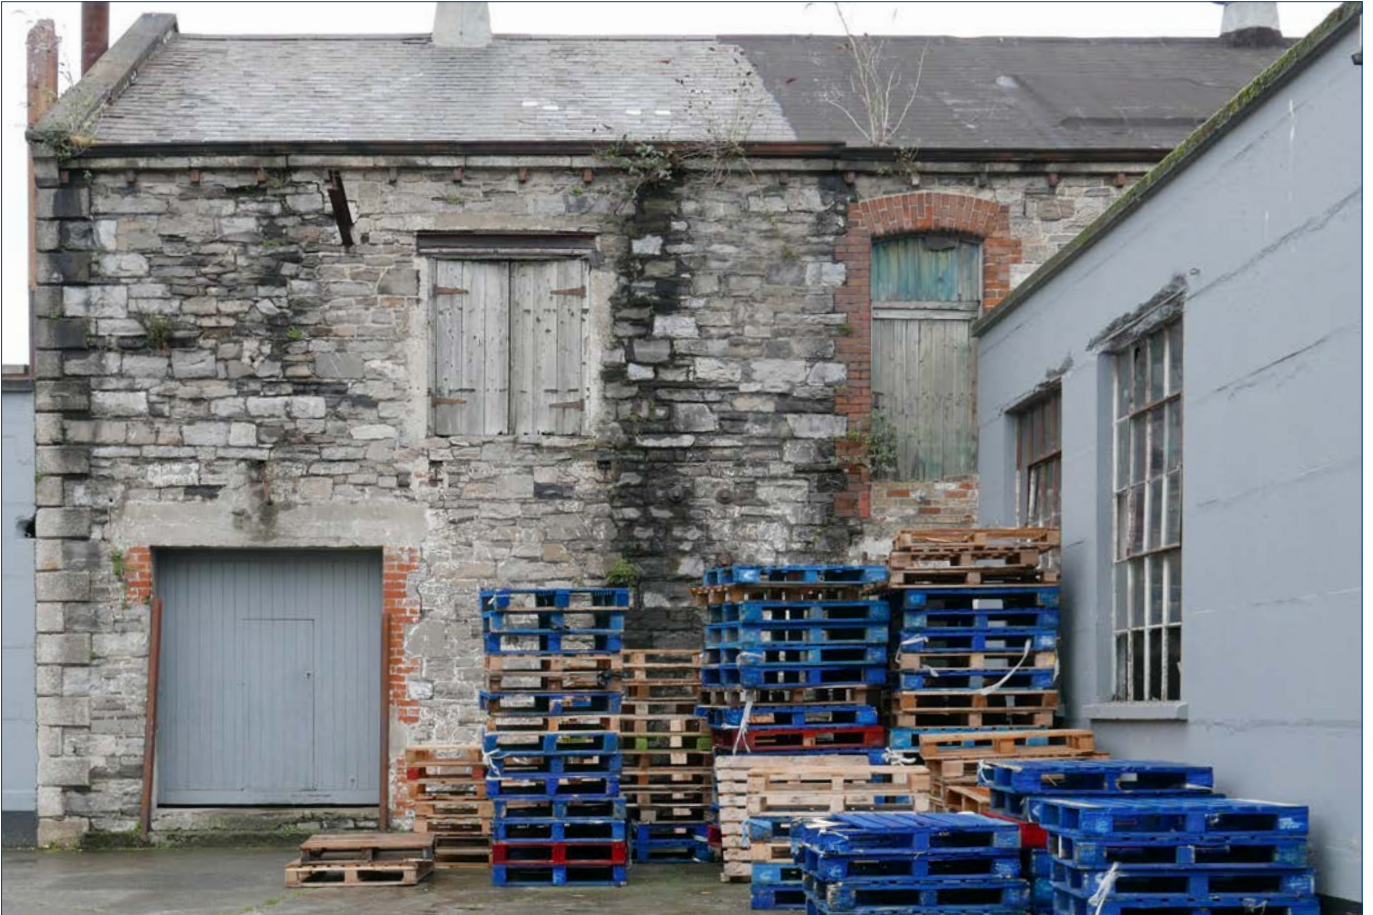
Large gabled building • north end of the west facade. Of the three openings seen in this view, only the opening to the right, with the brick trim, appears original.. The stonework is in need of cleaning, repair and repair of pointing. The slated roof needs to be repaired and reinstated.

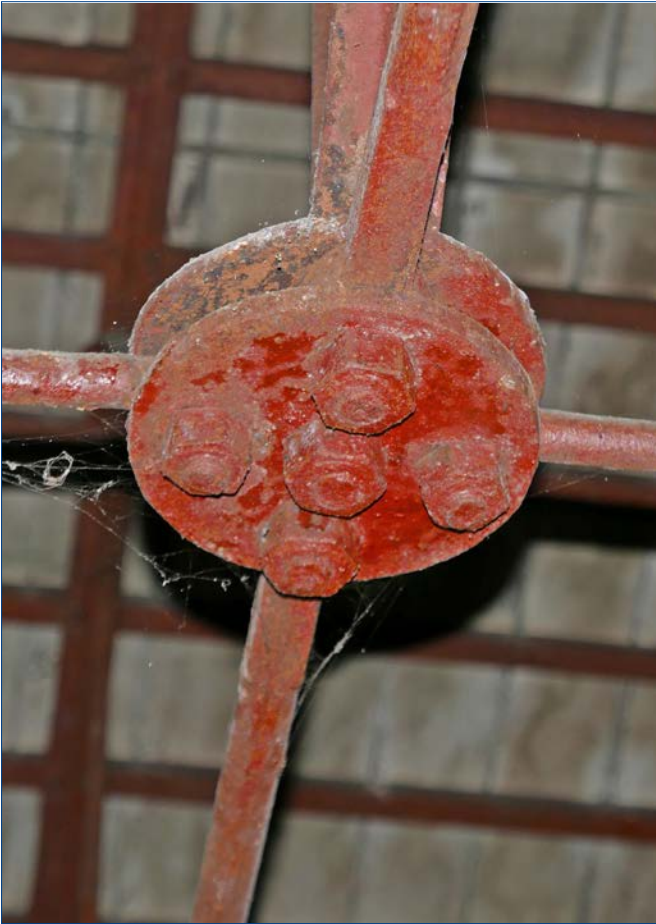
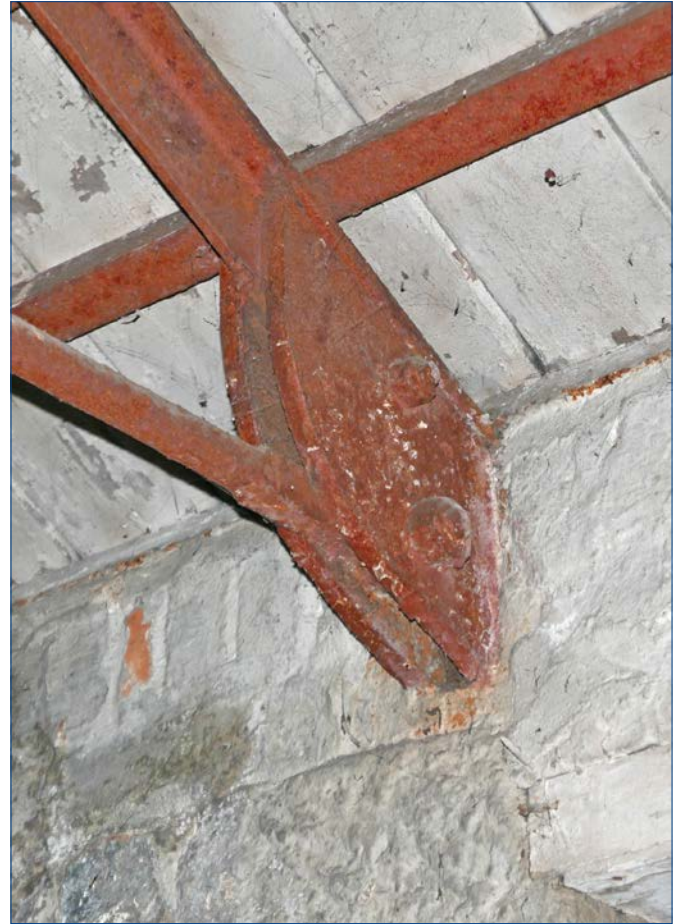
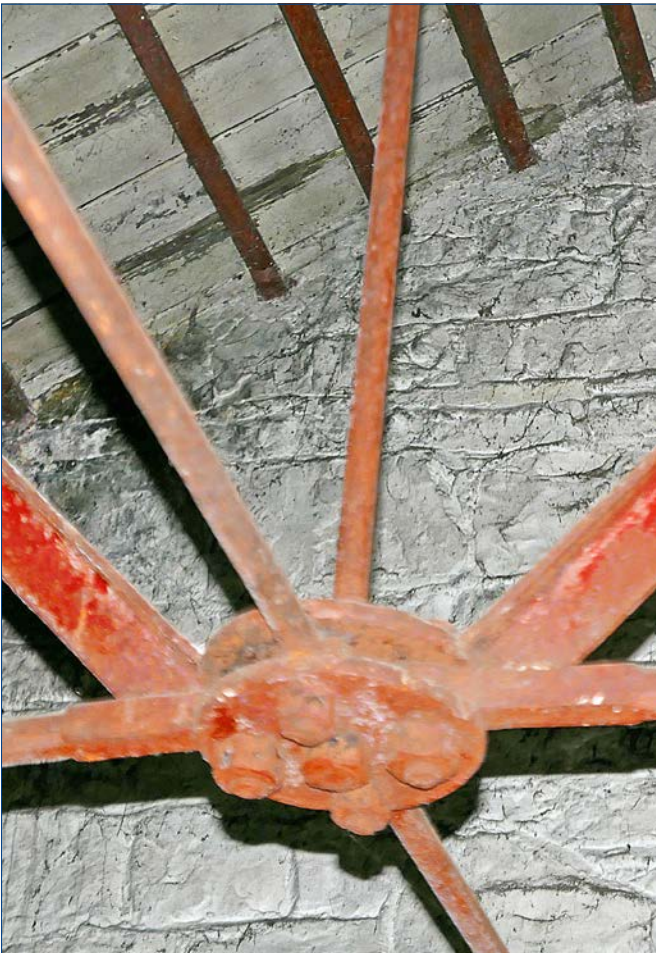
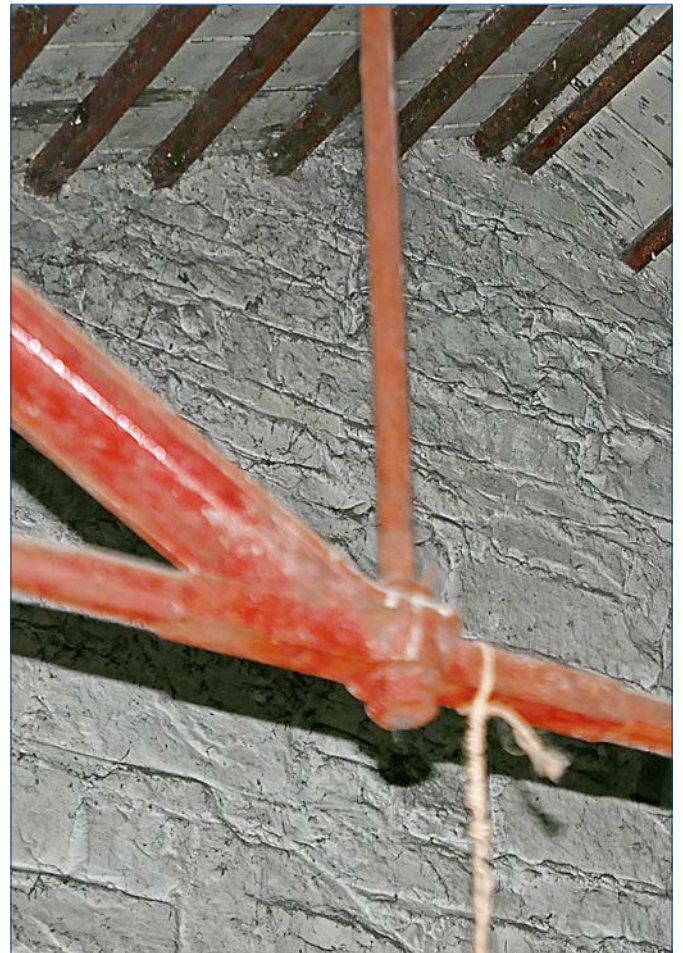
Details of steel roof trusses in the large gabled building. This steelwork is of modest heritage value. It is proposed that the steelwork in the roof of the large gabled building will be overhauled and retained.

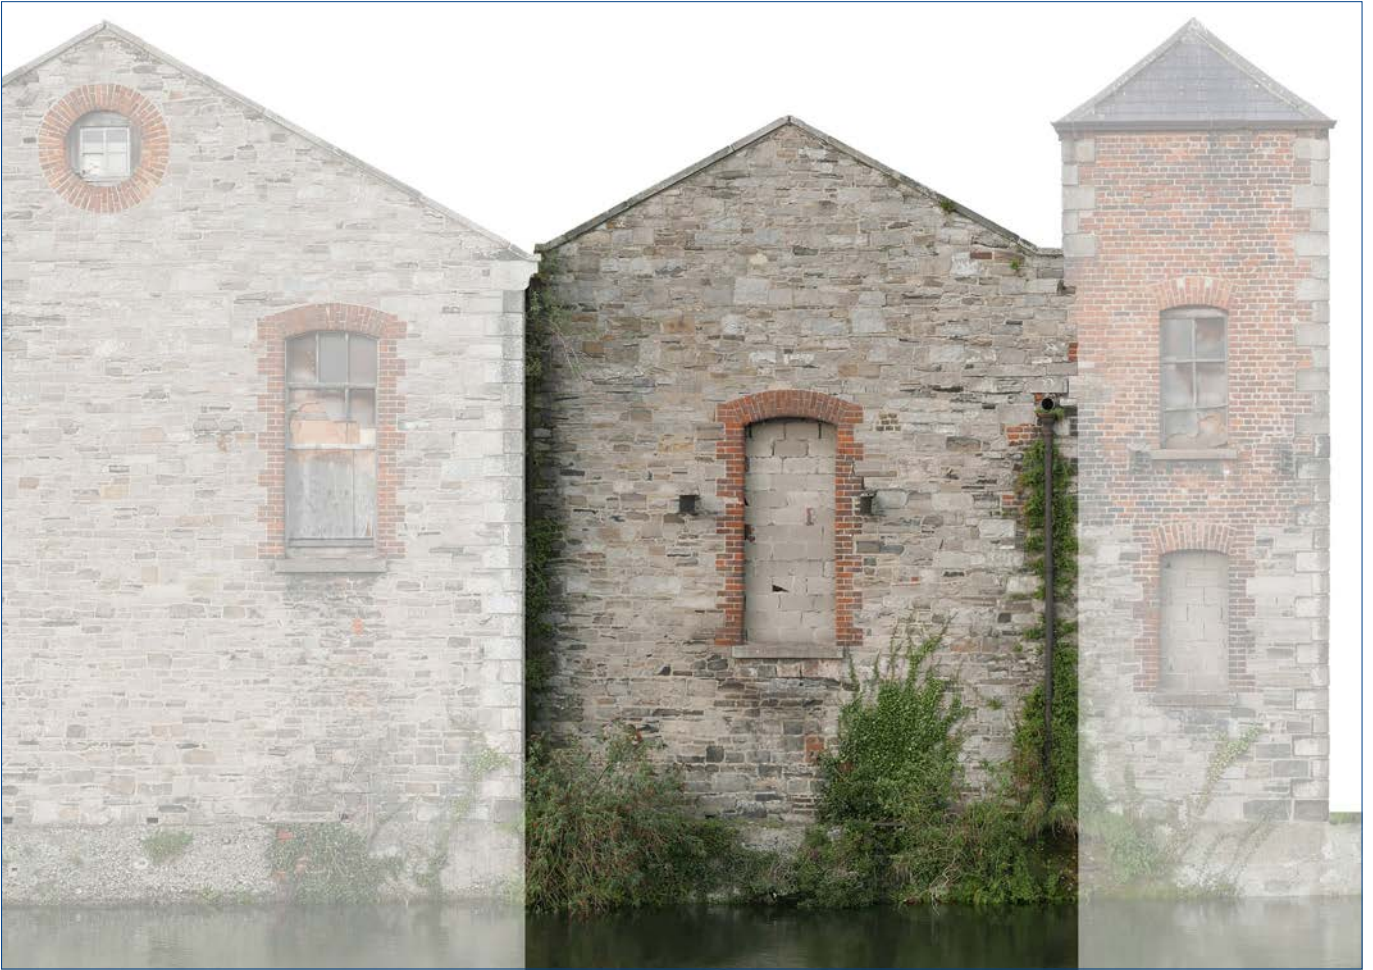
Rectified Elevation of the Smaller Gabled Building • Scale 1:100

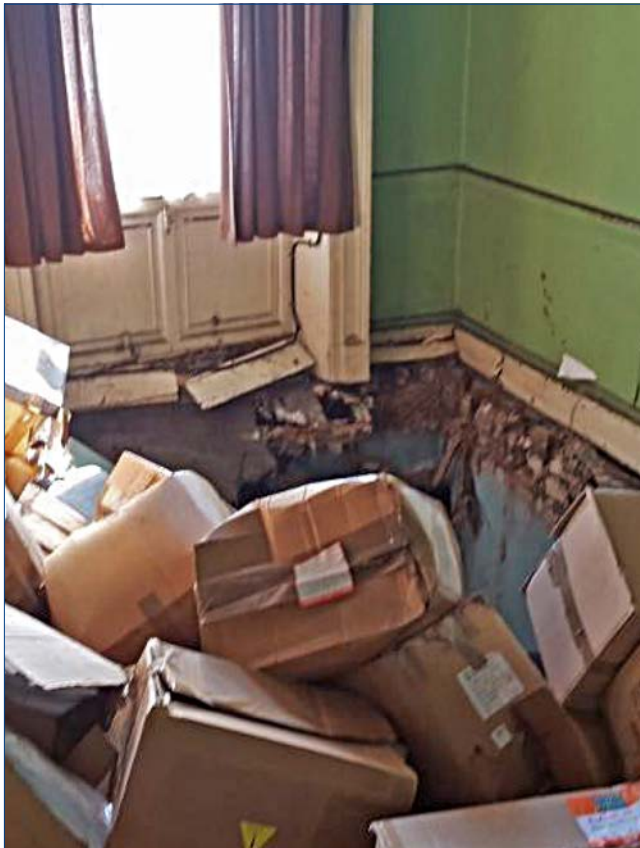
Interior view of 'Kingsbridge House' showing the ground floor partially collapsed into the basement. This image is from a report dated September 2016 by DBFL Consulting Engineers.

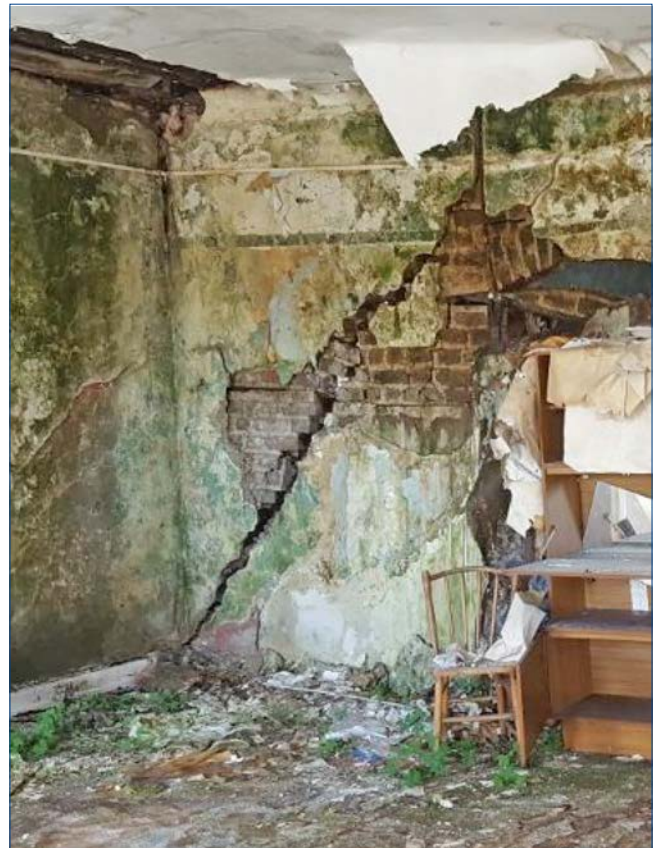
Interior view of 'Kingsbridge House' showing the structural failure of an internal spine wall. This image is from a report dated September 2016 by DBFL Consulting Engineers.
