Cultural Heritage Impact Assessment

LRD at 42A Parkgate Street,  
Blocks B1 and C,  
Dublin 8

Ruirside Developments

05/12/2024

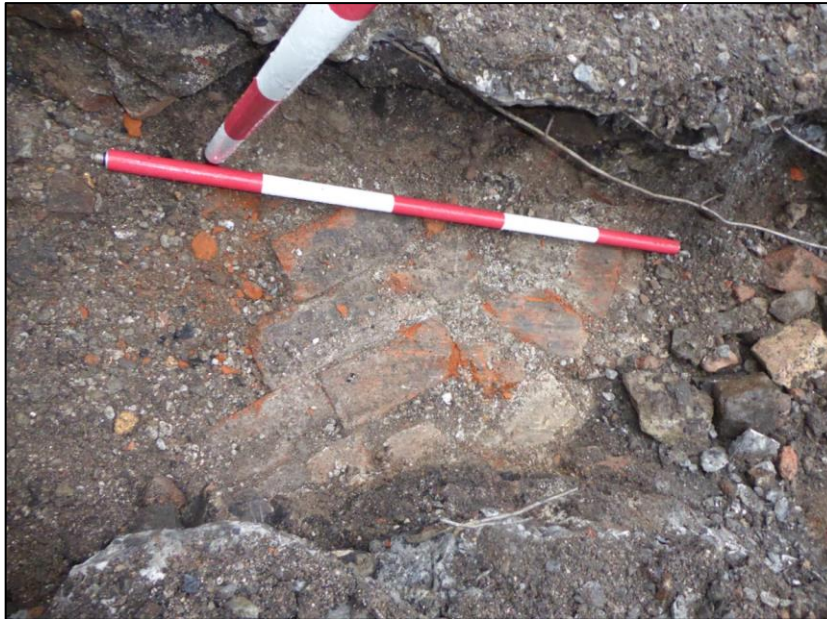
Plate 9 Unbonded red brick floor, test pit 5

0.2-0.80m	Loose mid grey silt with red brick fragments and flecks of mortar	20 <sup>th</sup> century industrial waste
0.80-2.6m	Dry limestone wall located to E side of the trench at 0.80m deep. Stone sized from L 0.35m W 0.12m D 0.20m the smallest to L 1.20m W 0.42m D 0.12m the biggest. To the west side of the trench a dark grey organic silty clay deposit with fragments of animal bone At 1.7m deep, it was reached of what it seemed a solid surface/rock (or wall), not visible from the top. It was not possible to gain further insight.	19 <sup>th</sup> century structure

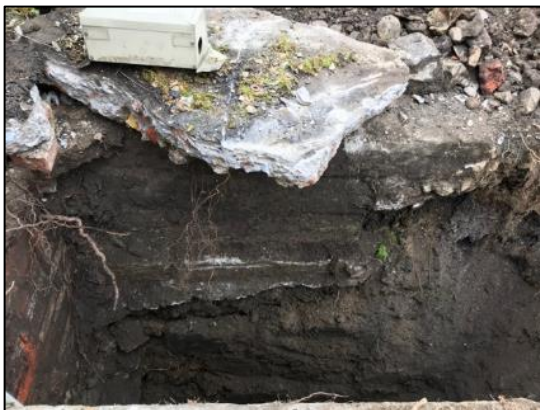
Plate 1 Concrete wall supports

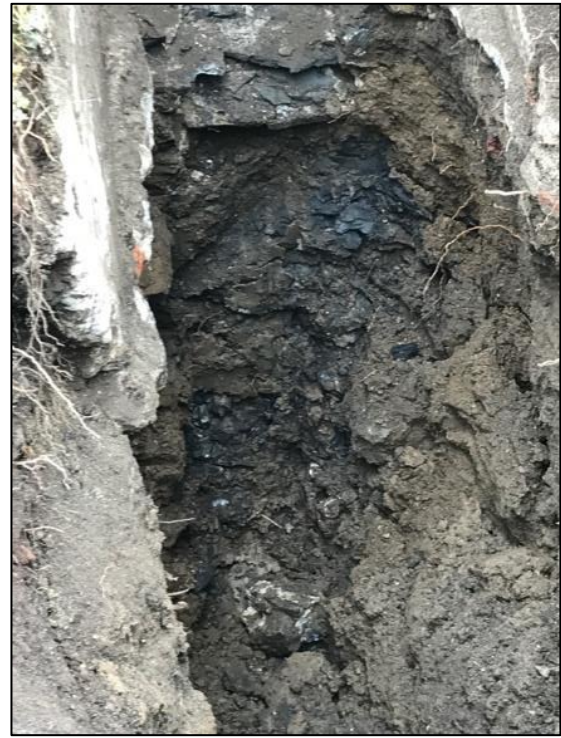
*Plate 4 Mudstone at base of quay wall*

TP 101 - River Trench - wall face		
Depth (BGL)	Description	Interpretation
2.20 – 0.00	Breeze block wall	Modern
0.00 – 0.15	Concrete	Modern
0.15 – 0.20	Layer of red brick set in sandy mortar	Demolition material
0.20 – 0.30	Brown clay friable	Garden soils
0.30 – 1.50	Red brick – c.10 courses visible with grey- white lime mortar	Wall
1.50 – 1.80	Small to average sized lime stones and mortar	Foundation of redbrick wall
1.80 – 2.20	Limestone blocks and large stones	Quay wall upper
2.20 – 3.80	Mudstone slabs and irregular shapes stones	Quay wall lower

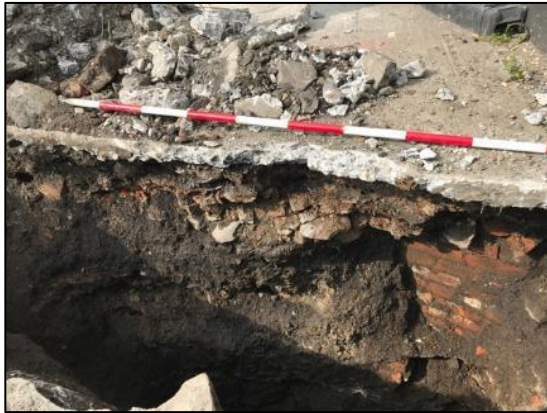
Plate 5 South-facing section of TP102

In the south-facing section, the remains of a redbrick structure were visible (seven courses in height and constructed over a drain) abutting the upstanding structure. This drain was lined with red brick, two courses deep, and capped with a layer of lime mortar. The lime mortar layer was evident across the section and possibly delineates the original ground level when the upstanding structure was constructed. The brown reclamation clays lay directly under this mortar layer.

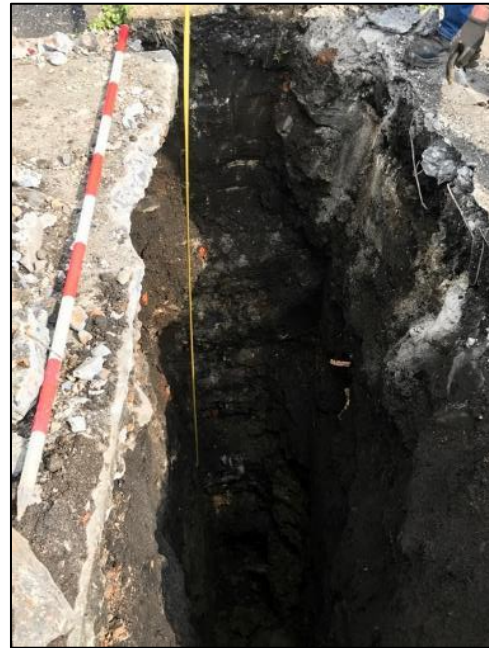
Plate 6 West-facing foundations of structure TP102

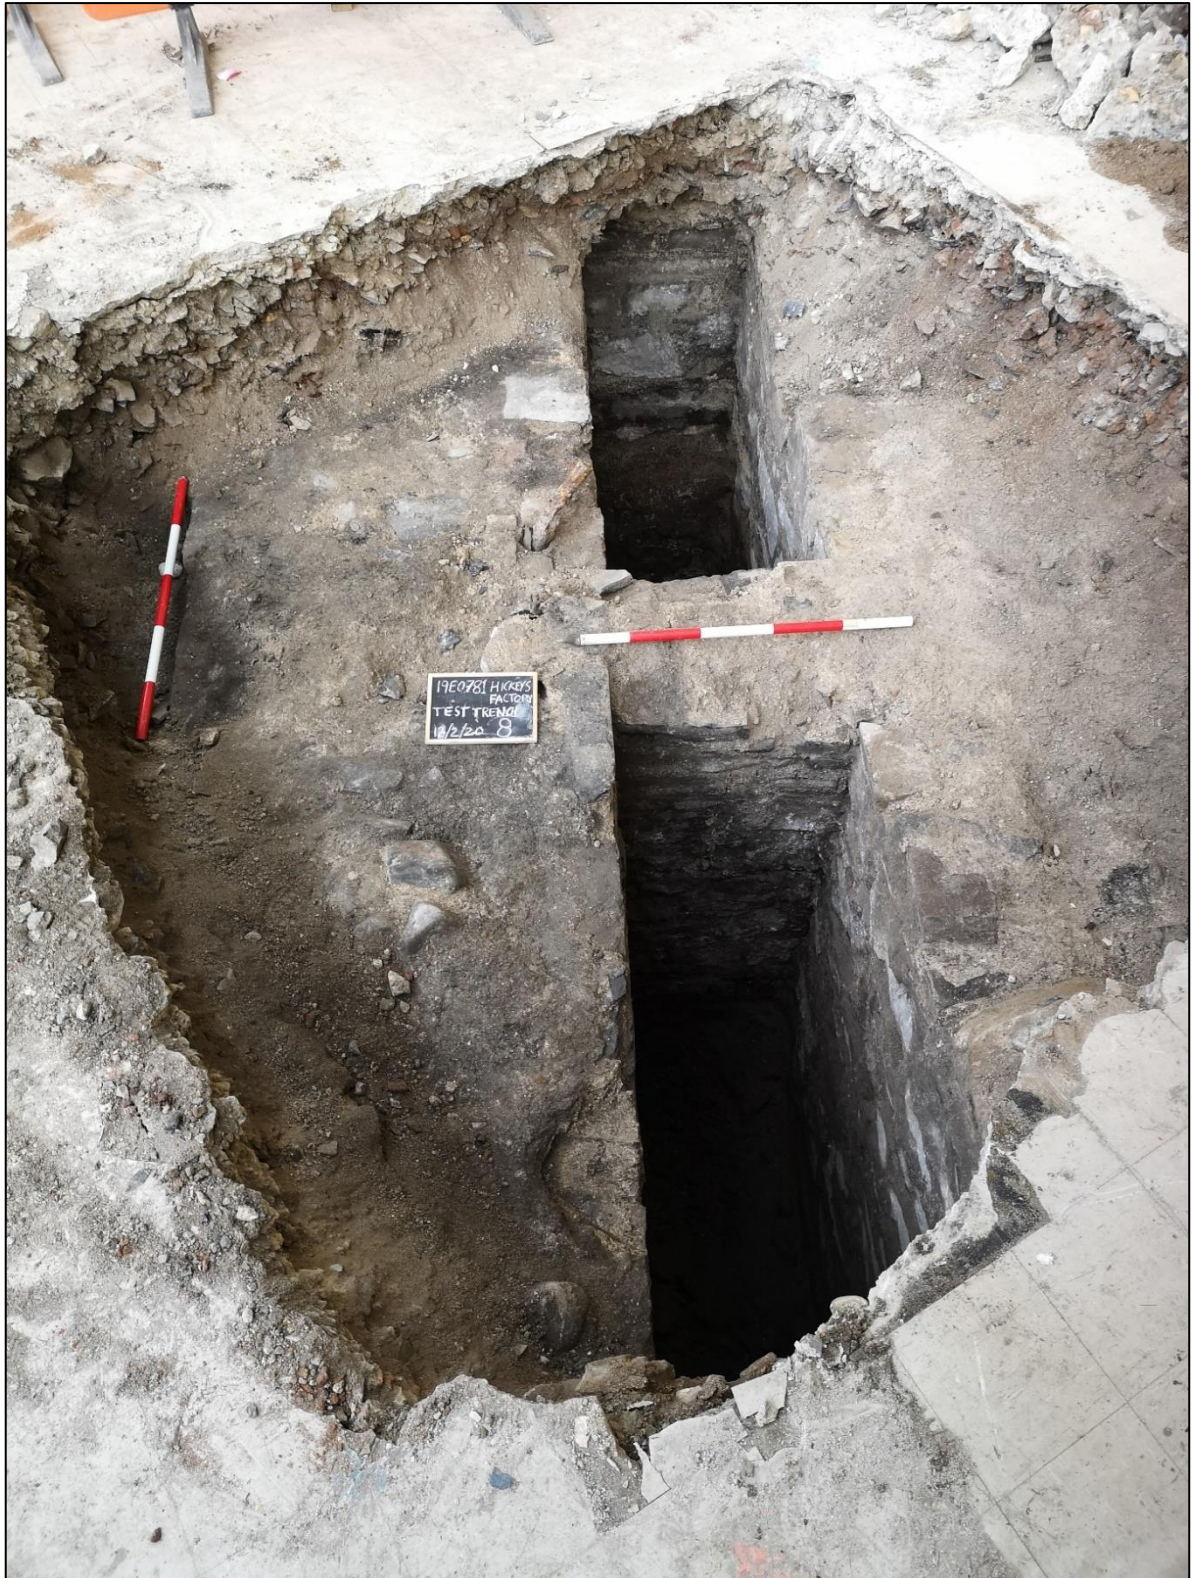
Plate 19 Test Pit 8 looking southeast showing the possible limestone flue structure, view to southeast

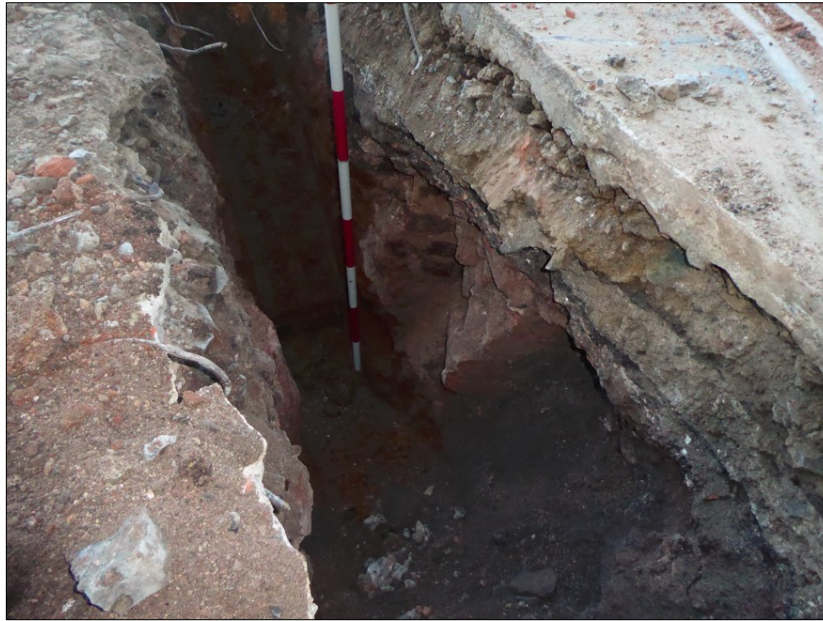
Plate 2 Wall in trench 19 northern side of the trench.

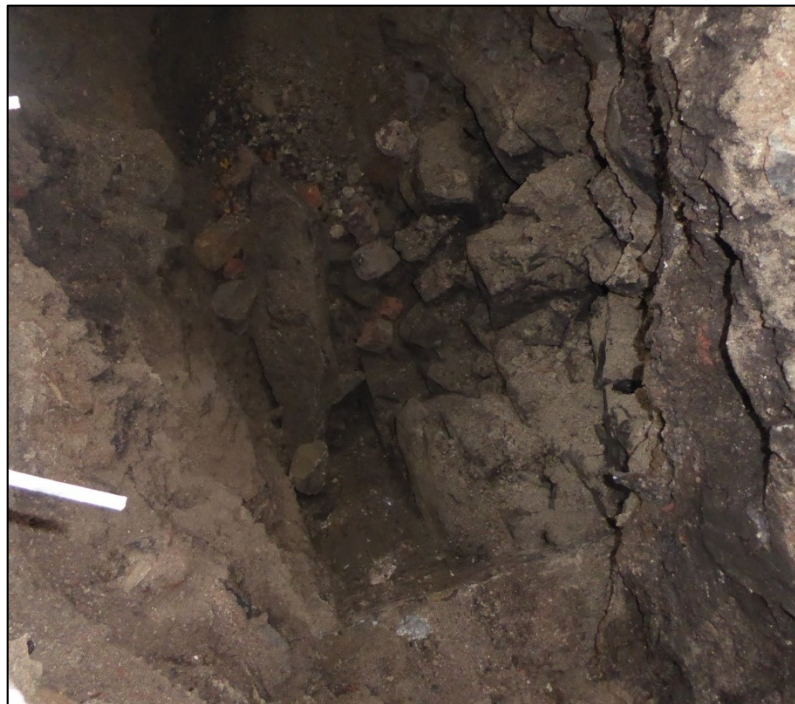
Plate 3 Test pit 15, possible masonry remains

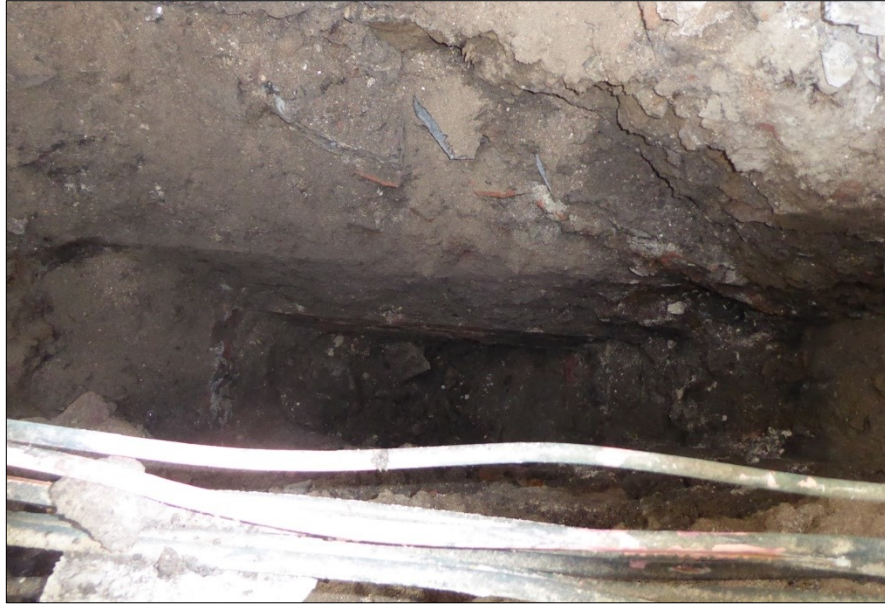
Plate 4 Test pit 17, Red brick wall on eastern side of the trench

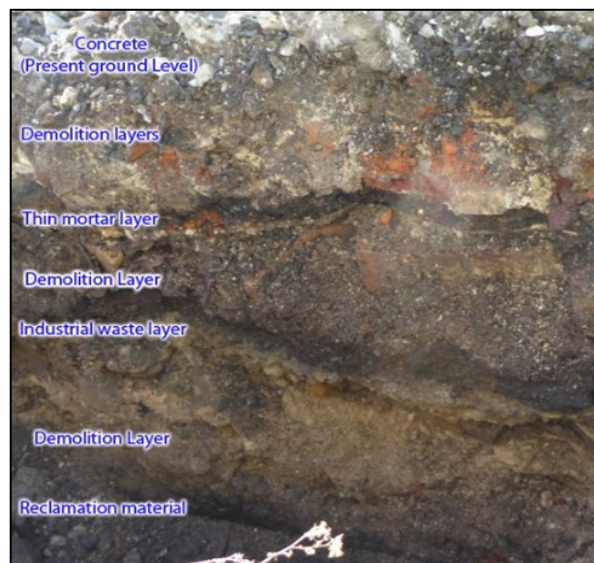
Plate 7 Typical cross section of upper levels, photo of TP5

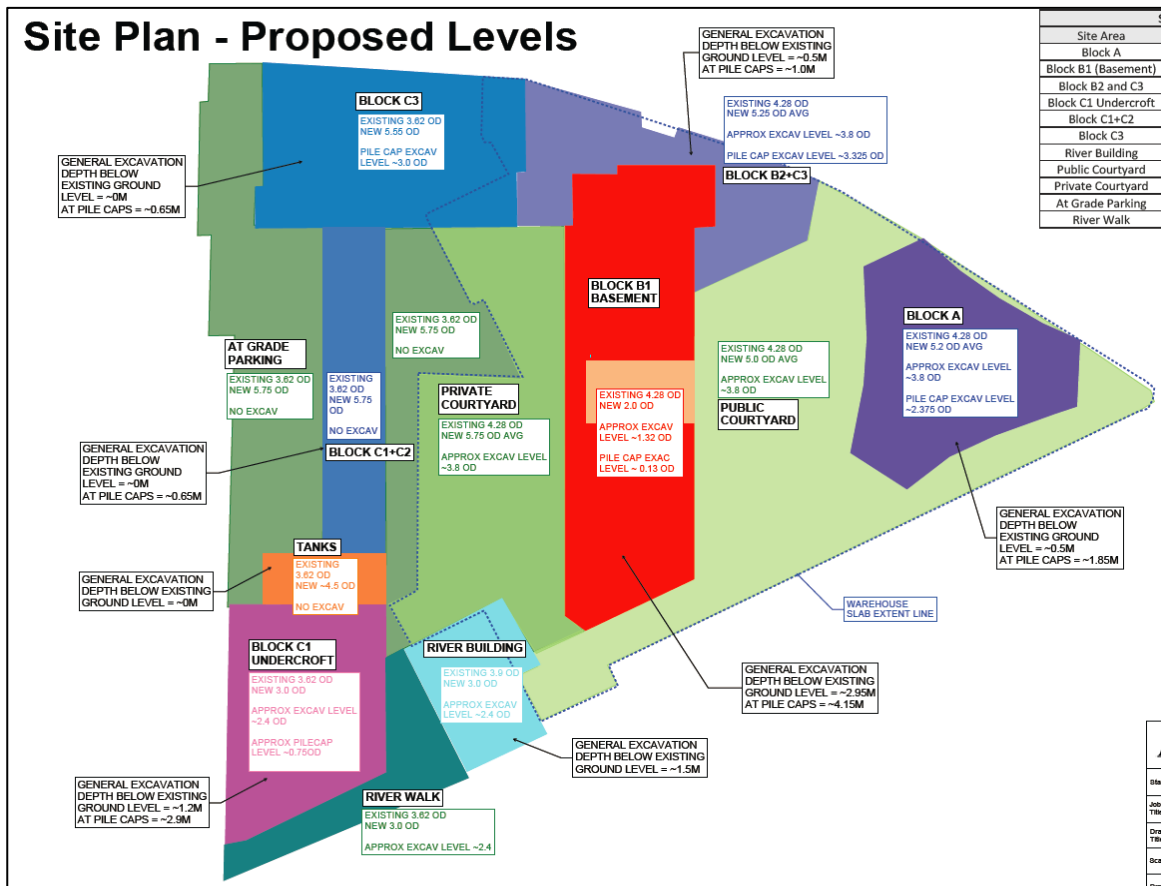
Figure 16 Site Plan excavation levels (see summary table above for detail)
